Geomorphic Assessment of the Stability of the Roaring Fork River Through the City of Aspen, Pitkin County, Colorado

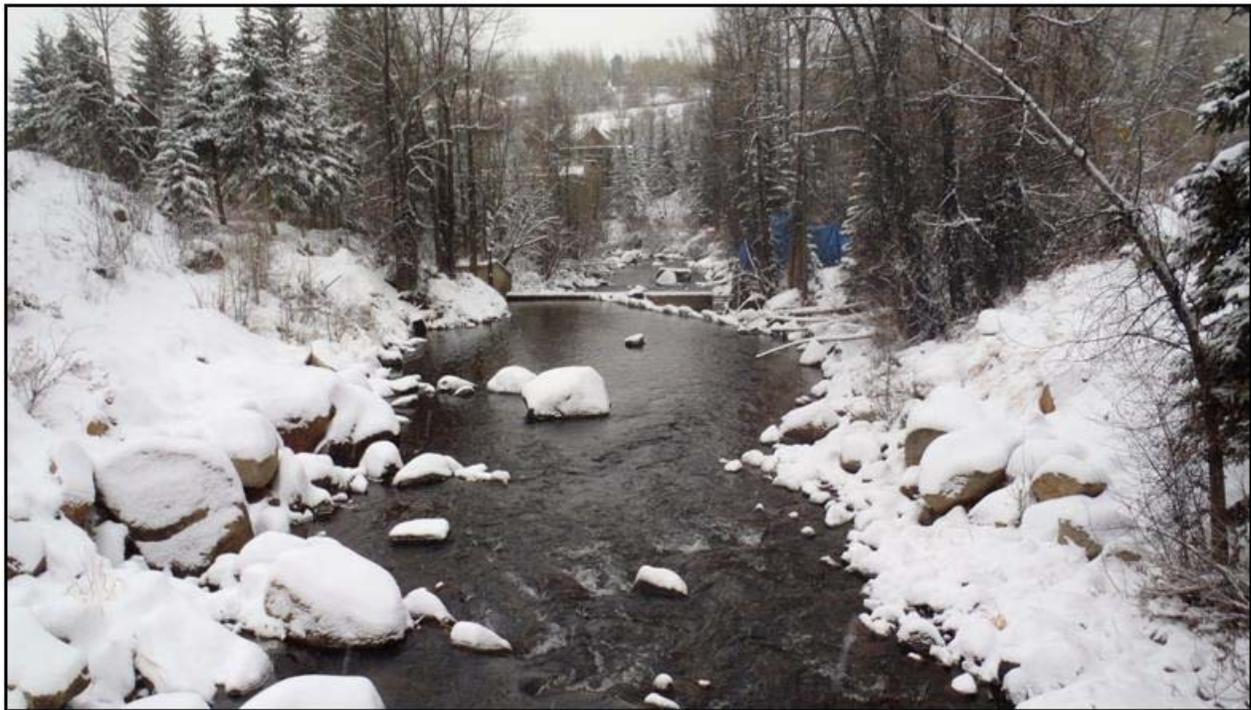
Immediately downstream of the Stillwater Drive bridge, the channel is heavily confined by armored banks. The Salvation Canal diversion dam, which creates a significant grade drop in the river, is located about 180 feet downstream of the bridge. **Figure 5** shows the confined channel with armored banks and the Salvation Canal diversion structure. Downstream of the structure, the river returns to its relatively unconfined and freely meandering form until about the Aspen Club location. Two cobble/boulder diversion structures are present in the river in the area of the Aspen Club (**Figure 6**). One is a right bank cross-channel diversion structure present just to the east of the Aspen Club and one is a side-channel diversion structure located on the left bank just downstream of the club. Except for the Salvation Canal diversion structure, which is approximately 5-6 feet high, it appears that none of these structures is an impediment to fish passage during low flow.

Figure 5. View looking downstream from the Stillwater Drive bridge toward the Salvation Canal diversion structure.

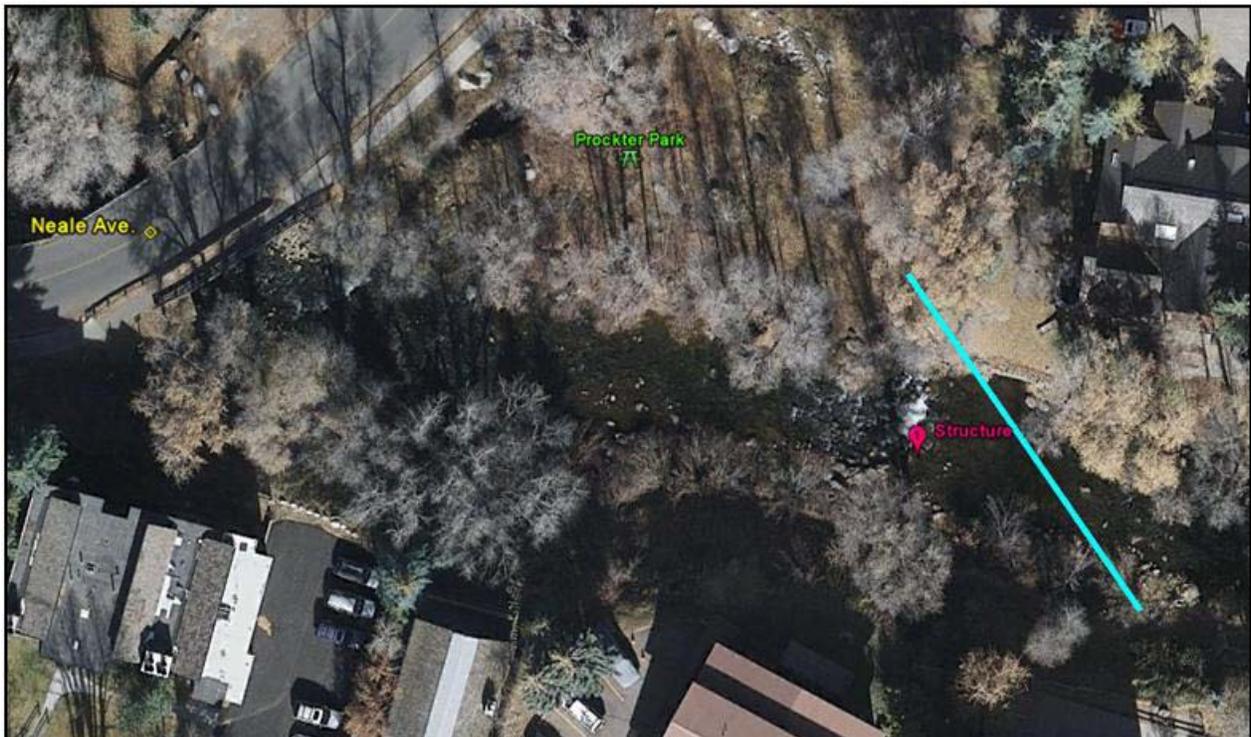
The first man-made cross-channel structure in the project reach occurs approximately 220 feet upstream of the Neale Avenue bridge (**Figure 8**). This structure, hereafter known as Structure #1, appears to be a grade control structure constructed of a series of boulders placed side by side across the channel (**Figure 9**). The vertical drop on the structure, which is evident in Figure 4, is about 1.5 to 2 feet. The structure is coincident with and downstream of a diagonal sewer pipeline crossing in the river. The pipeline, which was not evident at the time of the site visit, is about 15 feet from the grade control structure at its closest point (on the right bank) and about 65 feet at its furthest point (on the left bank). Although not observed at the time of the site visit, based on the 2008 aerial photos, a pool has developed just upstream the grade control structure and appears to be filling with finer grained sediment. Flattening of the channel slope upstream of the structure is also evident in Figure 4. It also appears that the right bank just upstream of the structure has been protected with revetment. A revetment is a form of bank protection, either as a slope paving or a retaining wall, constructed from a variety of materials including quarried stone, boulders, or other erosion resistant materials. In most cases, the bank revetment along the study reach of the Roaring Fork River consists of dumped or stacked quarry stone or boulders.

Figure 8. Aerial view of the location of boulder Structure #1 and a sewer pipeline crossing (light blue line) just upstream of the Neale Avenue bridge.

At this time, we would recommend that the Healthy Rivers and Streams Program, in cooperation with the City of Aspen and Pitkin County reconstruct Structures #1-3 using a series of weirs similar to that described in Figure 25.

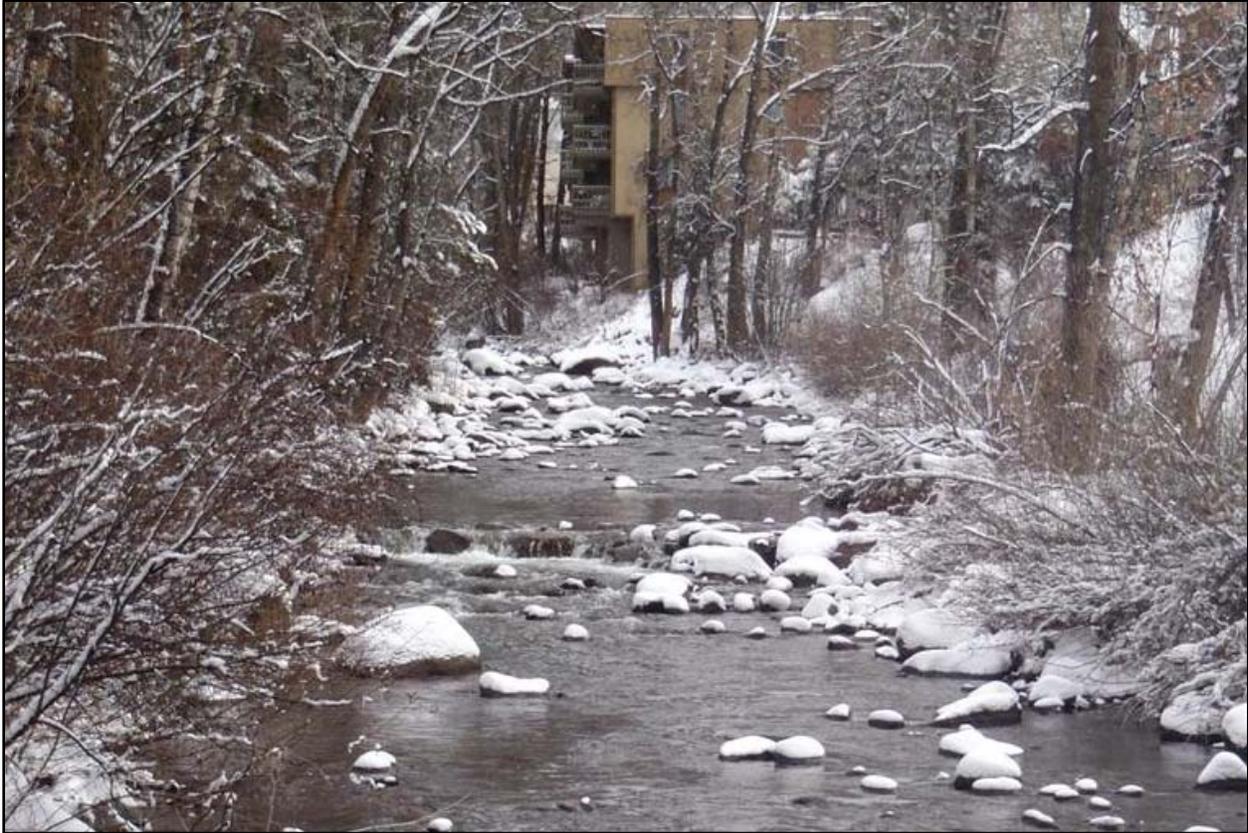
Although Figure 8 would suggest that fish passage may be possible on the right side of Structure #1, the apparent 1.5 to 2-foot drop may be too much during lower flows for fish to overcome. In addition, the fine sedimentation in the pool upstream of the structure may ultimately fill the pool and create very shallow conditions immediately upstream of the structure. These shallow conditions may not be conducive for fish passage during low flows and may also induce bank erosion by forcing flow to the sides of the channel.

Figure 9. View looking upstream from Neale Avenue bridge toward the cross-channel boulder Structure #1.

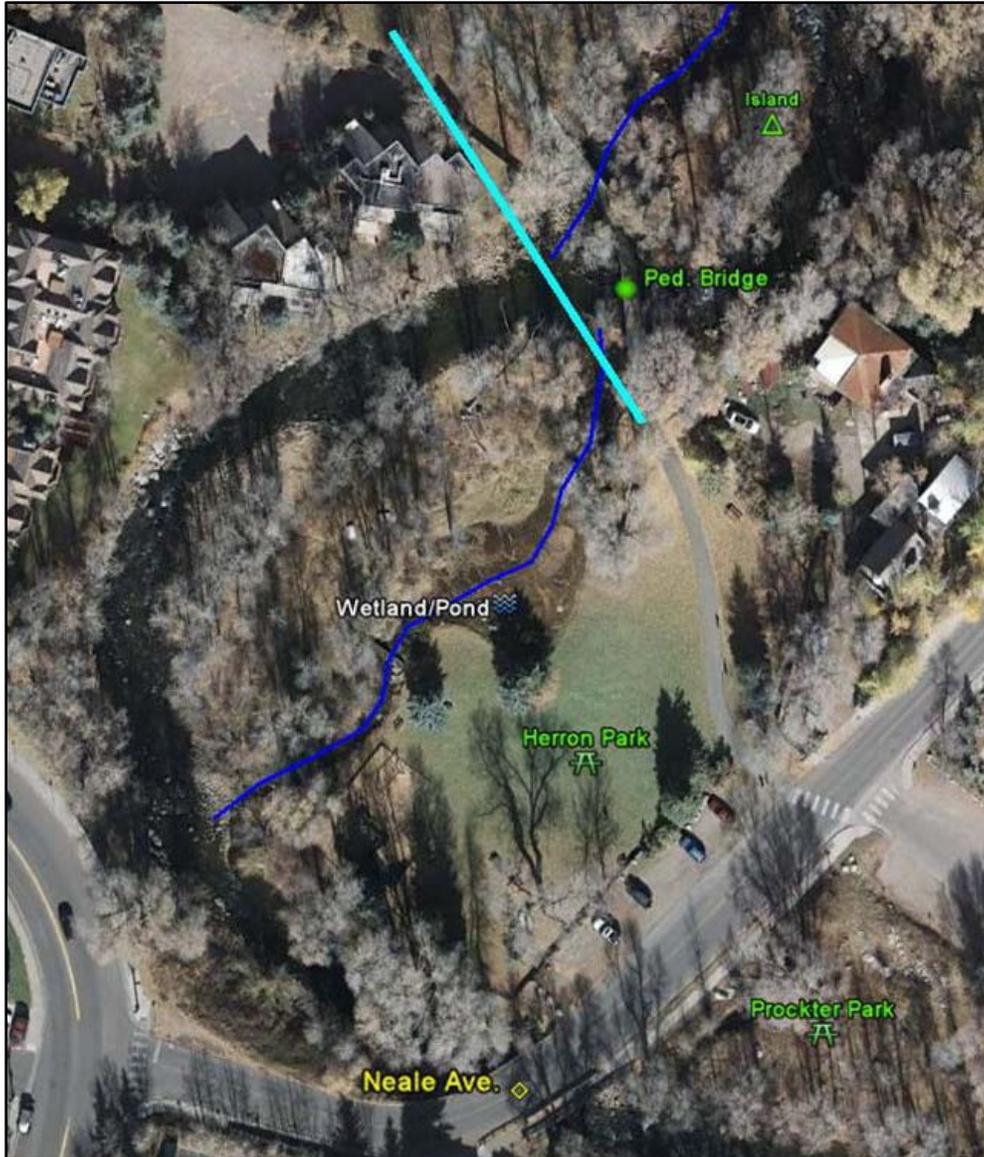
The next segment, known as the Herron Park segment, extends from the Neale Avenue bridge to the pedestrian bridges about 600 feet downstream (**Figure 10**). This reach is represented by a large radius left hand bend. The inside of the bend is cut by a man-made channel that intersects a wetland pond at about the center of the bend. The man-made channel continues downstream and intersects the river just upstream of the pedestrian bridge. The left or outer bank of the bend is revetted over most of its length within this segment.

Although not evident during the site visit, a sewer pipeline crosses the river just upstream of the pedestrian bridge (see Figure 10). Just downstream of the pedestrian bridge at this location is the site of an avulsion or cutoff of the channel across the inside of a right hand bend. Although not evident at the time of the site visit, any grade control placed in the river to protect the sewer line crossing at this site may have contributed to or induced the cutoff of the channel and the formation of the island there. In addition, the upstream cutoff channel at Herron Park may also have contributed to the cutoff downstream of the pedestrian bridge by forcing flow toward the left side of the main channel where the Herron Park cutoff channel rejoins the river at the pedestrian bridge.

Figure 10. Aerial view of the Herron Park segment of the project reach showing the pedestrian bridges at the downstream end of the segment, the sewer pipeline crossing (light blue line) just upstream, and the man-made split flow channel (dark blue line) and wetland pond at the park.

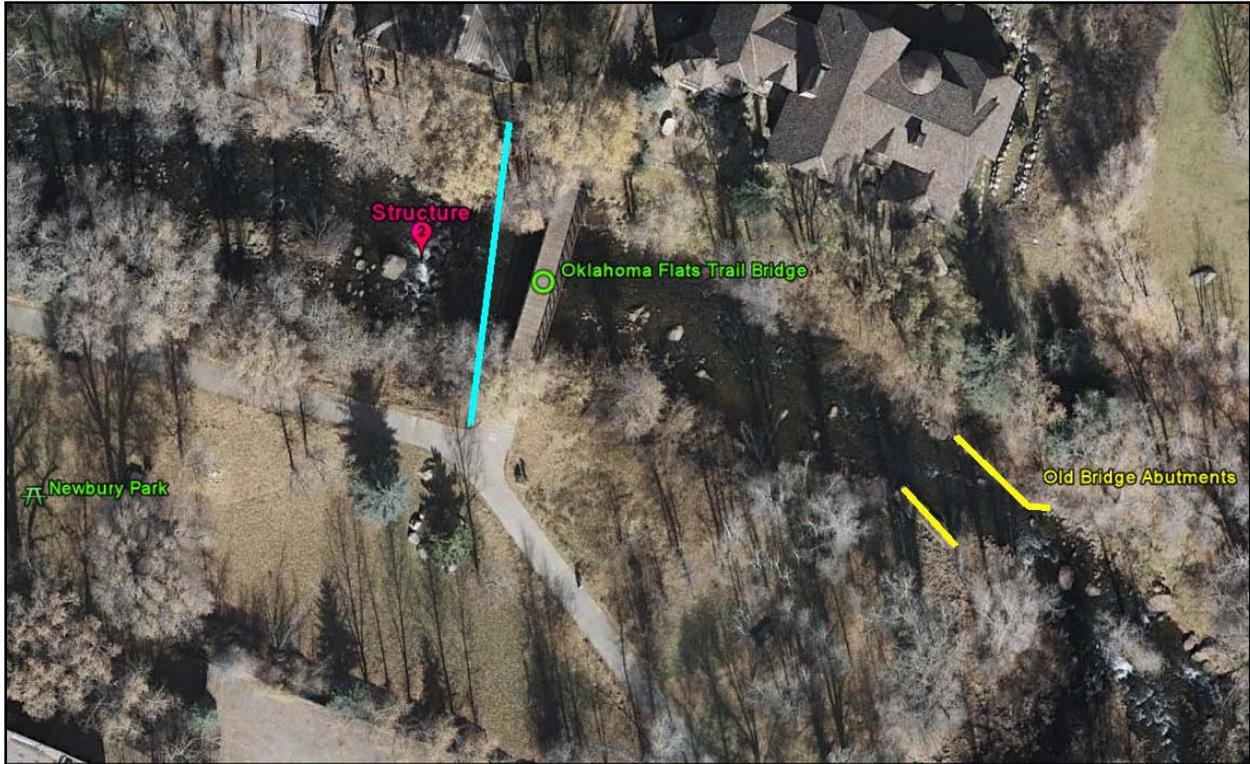
The next man-made structures in the river are two old concrete bridge abutments on the banks of the channel about 140 feet upstream of the Oklahoma Flats Trail pedestrian bridge over the river at Newbury Park (**Figure 11**). These abutments do not obstruct flow or create any significant problems in terms of channel processes, but do create a slight constriction in the channel width. About 35 feet downstream of the pedestrian bridge is the another cross-channel boulder grade control structure, Structure #2, which also creates an impediment to fish passage at low flows. As shown in Figure 11, the structure was placed to protect an exposed sewer line crossing located about 20 feet upstream. Figure 11 shows the relationship of the structure to the channel and the sewer line crossing. **Figures 12 and 13** show the alignment of Structure #2, which has a drop of approximately 1.5 to 2 feet over the crest. The drop at Structure #2 is also evident in Figure 4.

Figure 11. Aerial view of Structure #2 relative to the sewer line crossing (light blue line) just downstream of the Oklahoma Flats Trail pedestrian bridge at Newbury Park.

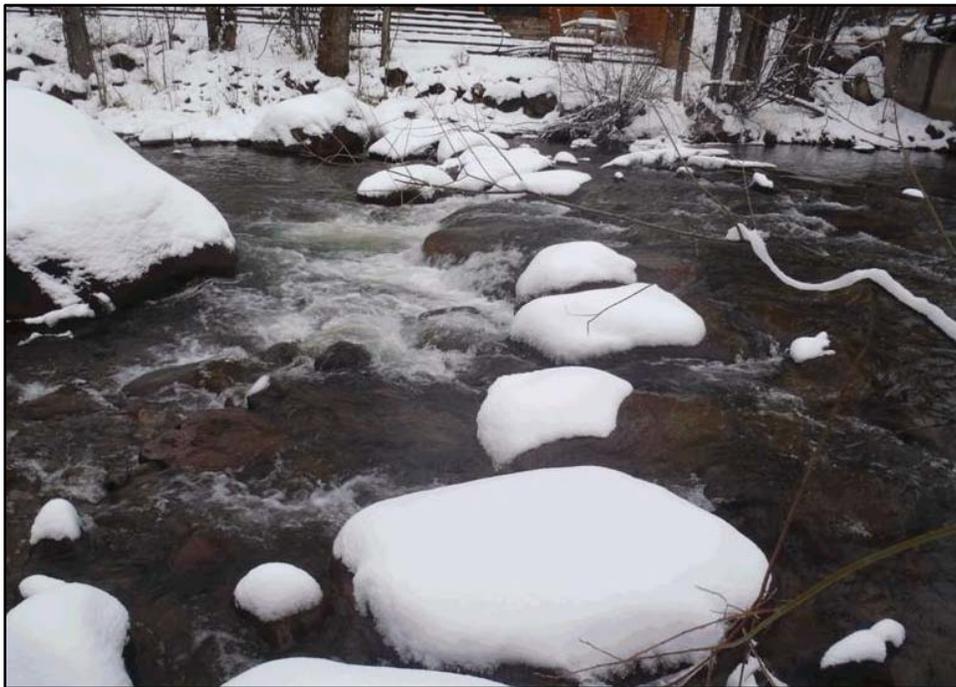
Figure 12. View looking toward the right bank showing Structure #2 just downstream of the Oklahoma Flats Trail pedestrian bridge at Newbury Park.

Although the flows seen in Figure 12 appear to be sufficient to allow for fish passage, summer low flows may be significantly less and may not be sufficient to allow for fish passage. In addition, Structure #2 is creating sufficient backwater upstream to cause finer grained sedimentation in the channel for some distance upstream of the pedestrian bridge (**Figure 14**) due to the reduction in the energy slope created by the structure. This sediment appears to be finer than the substrate sizes necessary for spawning and appears to be partially burying or infilling the spawning substrate at this location. Small scour holes have developed off the downstream face of the structure.

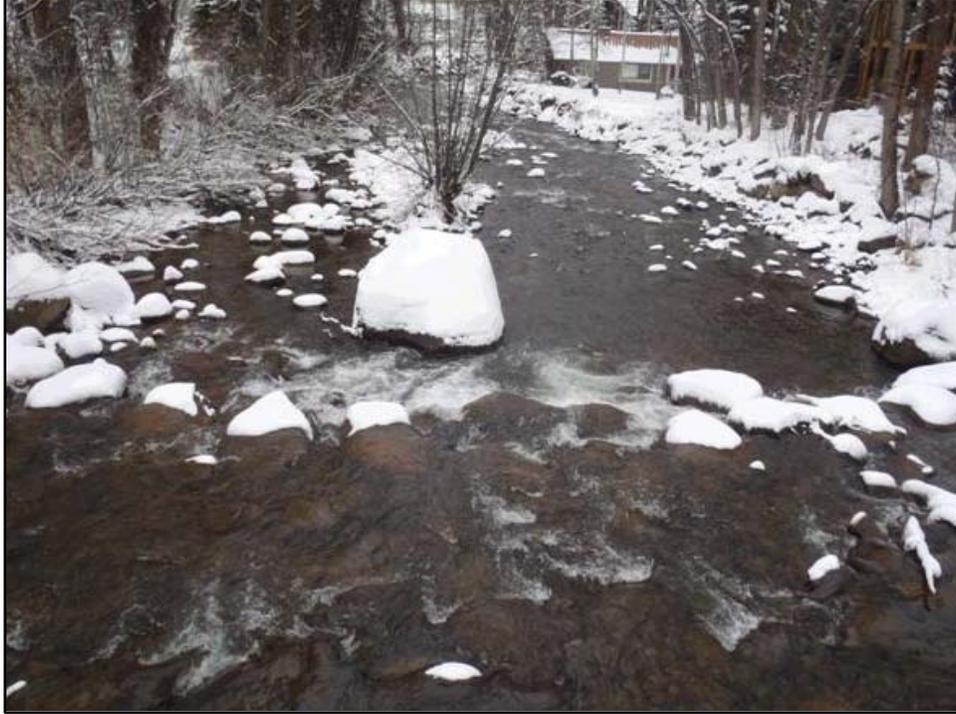
Figure 13. View looking downstream from the Oklahoma Flats Trail pedestrian bridge. Note Structure #2 and boulder revetment along the right bank downstream.

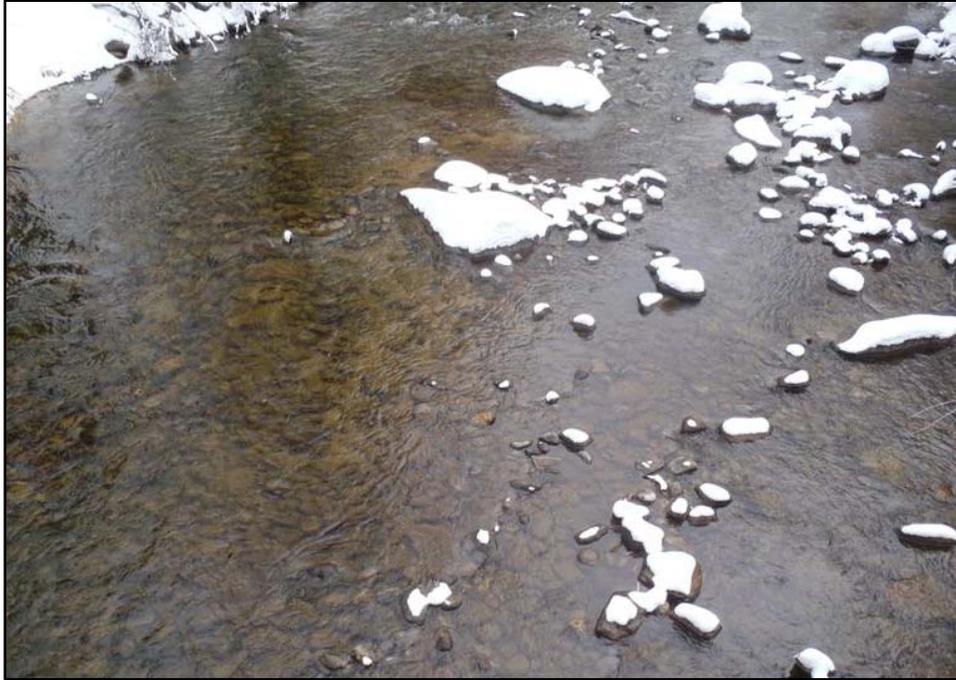
Figure 14. View looking upstream at aggradation induced by Structure #2 upstream of the Oklahoma Flats Trail bridge.

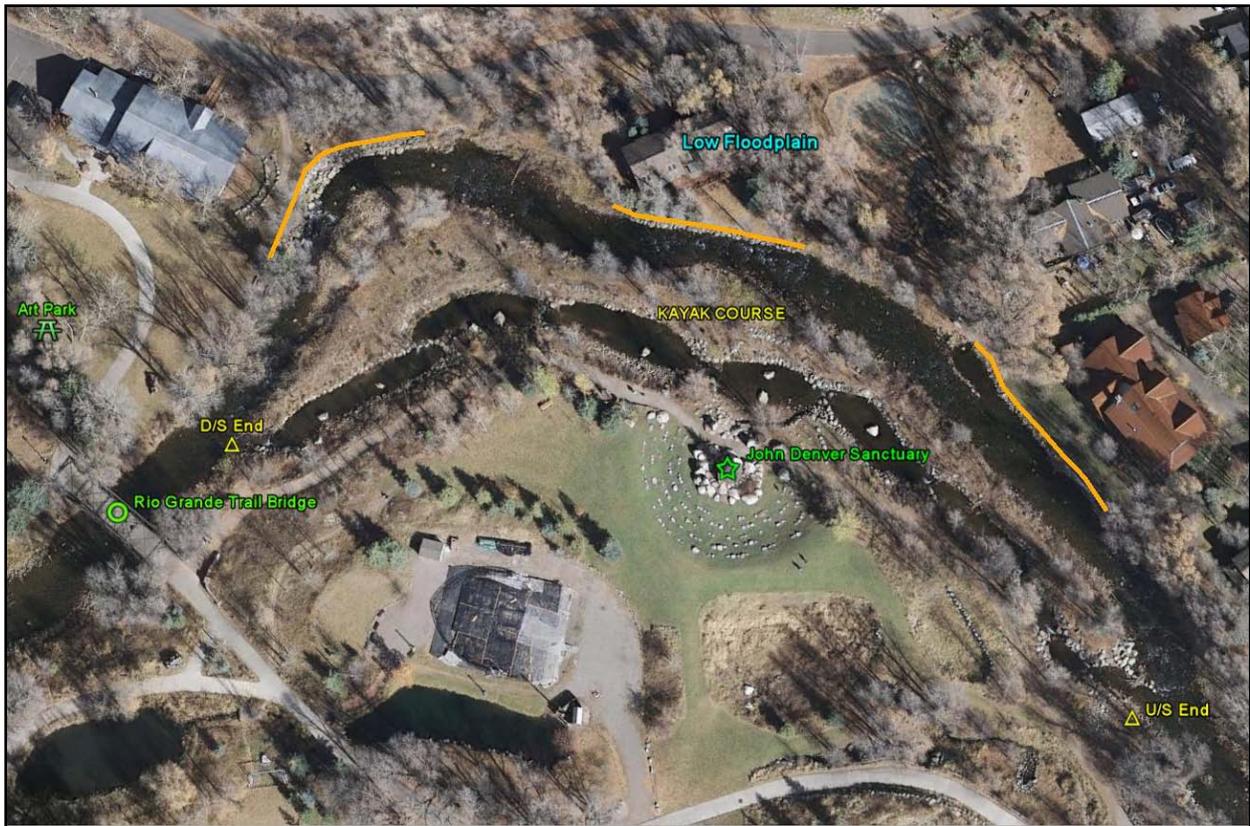
The lower portions of both banks of the river are revetted with large boulders over much of the reach from the Oklahoma Flats Trail pedestrian bridge to the upstream end of the kayak park at the John Denver Sanctuary, a distance of about 590 feet. The kayak course located at the John Denver Sanctuary is situated on the inside of a large radius right hand bend which makes a sharp turn to the west near the Aspen art museum in Art Park (**Figure 15**). The kayak course, which diverts water from the main channel, covers a length of approximately 675 feet, whereas the river length over the same reach is approximately 815 feet. The grade drop for both the kayak course and the river in this reach is about 10-11 feet. Boulders placed in the river at the upstream end of the kayak course are strategically located in and across the channel to assist in the diversion of flow into the course (**Figure 16**). There are 7 pools and 8 boulder drop structures or sluiceways within the kayak channel. **Figure 17** shows one of the drop structures and upstream pools relative to the main channel of the river and the intervening island.

Figure 15. Aerial view of the kayak course reach of the river at the John Denver Sanctuary.

There are a number of potential problems associated with the kayak course that impact river function. First, the course diverts flow from the main channel for its use. Since the width of the main channel through this reach has been maintained, the flow diversion into the kayak course results in shallower flows in the main channel during low to moderate flows. Second, the reduced flows in the main channel can also result in fine grained sediment deposition, which may limit the availability of spawning substrate. Also, during higher spring flows, a significant amount of sediment eroded from the unprotected banks of the kayak course as well as sediment transported in from the main channel is deposited in the pools of the course. Deposition of fine sediment within the pools as well as the trapping and deposition of organic materials may limit the viability of the course if not regularly removed. Finally, there are boulder drop structures at both ends of the course with the downstream structure having a drop of about 3.5-4 feet and the upstream structure having a 1-1.5 foot drop. These upper and lower structures create an obstruction to fish passage during low flows. During the moderate to high flows, fish may migrate or be diverted into the kayak channel and can become trapped in the pools once flows recede (this was readily evident during our site visit). The sediment and organic material deposition in the pools, the limited habitat, and potential summer heating of the water in the pools can be detrimental to any fish stranded in the kayak channel during the summer months.

With regard to the kayak park at the John Denver Sanctuary, we would recommend the complete removal of the course and reclamation of the area occupied by the course to a functional floodplain. Based on our knowledge of the course, it appears that the course is used infrequently and only when there is sufficient flow, such as during spring runoff. Thus, the course is only viable for a short period during the entire year and will likely require ongoing maintenance to keep the course pools clear of sediment and organic debris. The kayak channel could be reclaimed by removing the excavated material from the intervening island and refilling the kayak channel with little to no effect on in-stream habitat on the main channel of the river. By refilling the kayak channel, the floodplain area occupied by the island that was covered with the material previously excavated from the kayak channel would also be restored. Reshaping of the left bank of the river and replanting riparian vegetation on the reclaimed island/floodplain area would also contribute to habitat diversity in this reach.

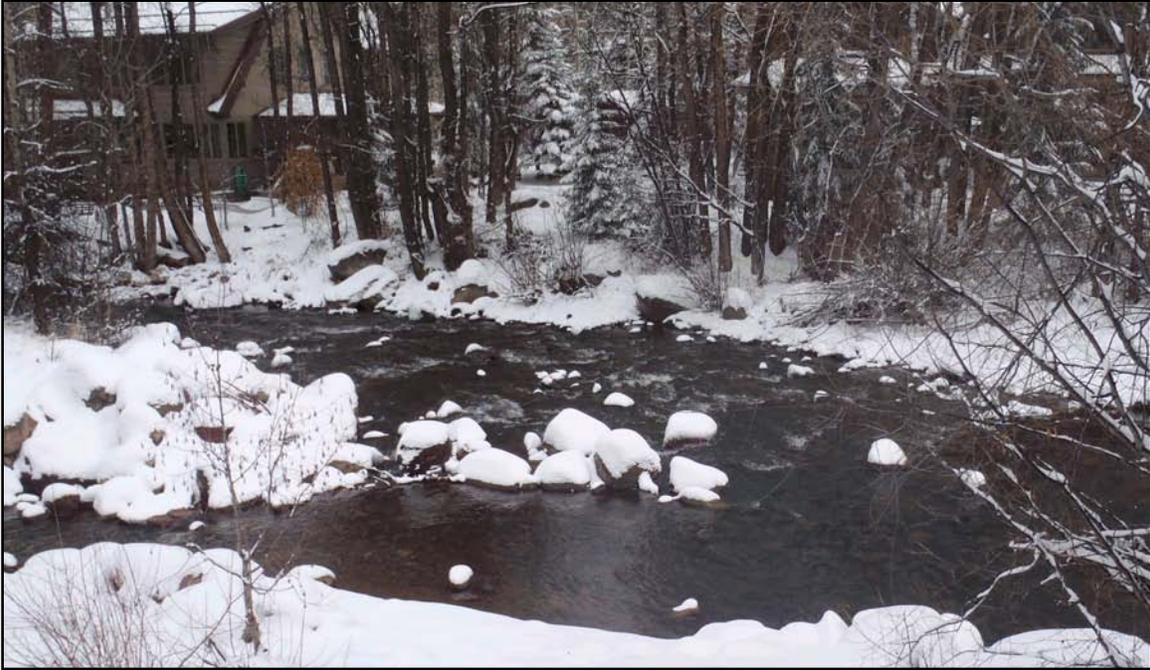
Figure 16. View looking downstream toward the right bank showing the boulder flow split and diversion into the kayak course channel.

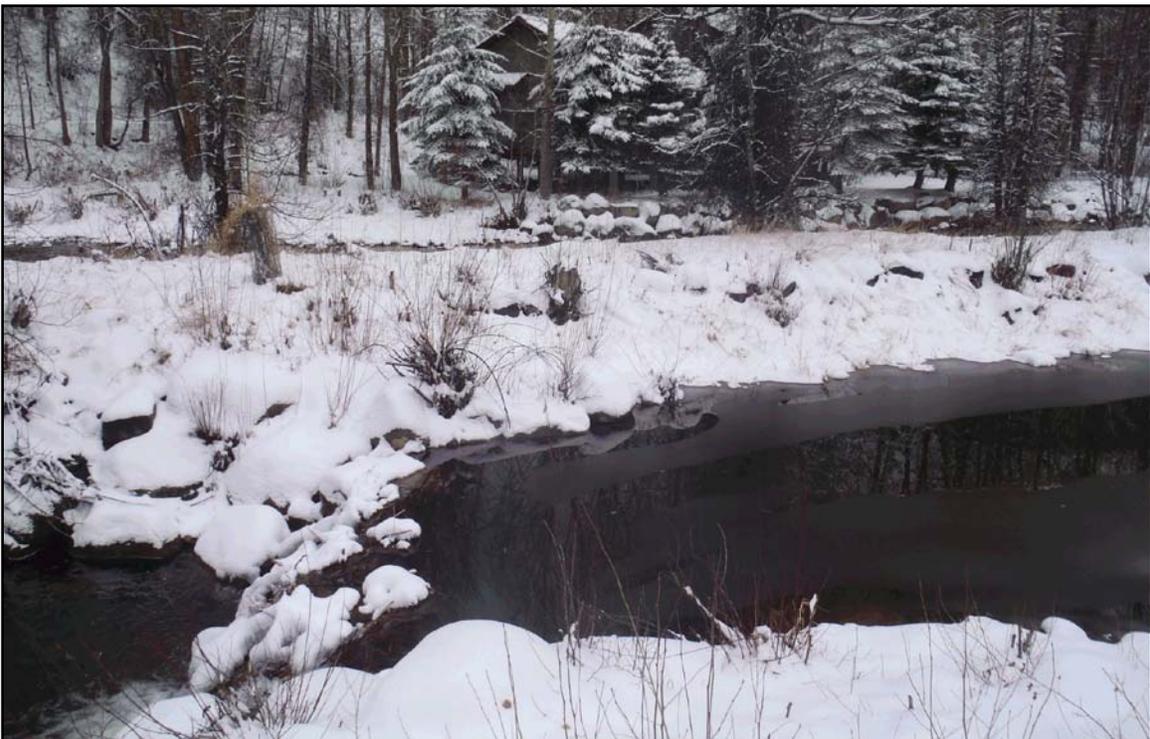
Figure 17. View toward the right bank showing a typical boulder drop structure and upstream pool in the kayak course channel and the main channel of the river in the background. Note the high island between the river and the kayak channel. A remnant of the low floodplain is in the background. Note the house on pilings.

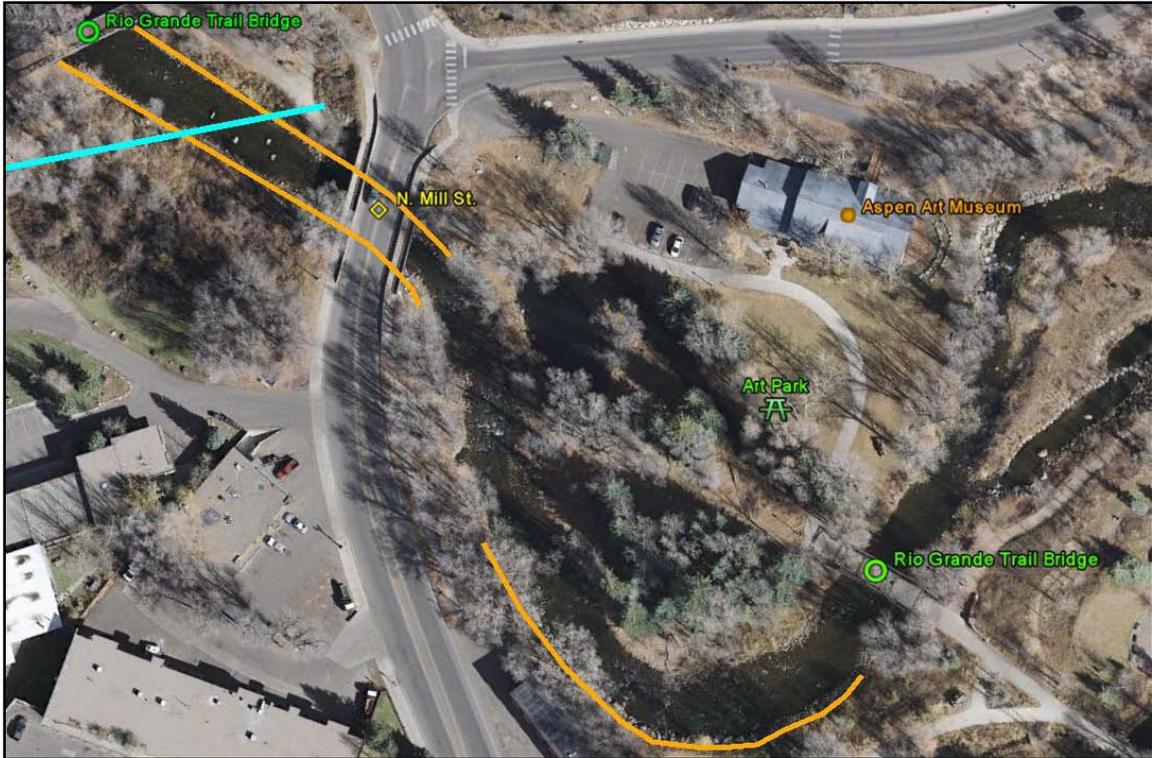
The river then passes under an old railroad bridge on the Rio Grande Trail just downstream of the end of the kayak course. From there, the river makes a sharp left hand bend, turning back to the north (**Figure 18**). The left or outer bank in this bend is revetted with large boulders, whereas the right bank and low floodplain of Art Park is defined by man-made wetlands/ponds. The river then passes under the N. Mill Street bridge and then under a Rio Grande Trail pedestrian bridge about 200 feet further downstream. Both banks of the river are revetted between the N. Mill Street bridge and the pedestrian bridge. An unexposed sewer line (light blue line in Figure 18) passes under the river about half way between these bridges. Fish passage through this reach is unobstructed.

Figure 18. Aerial View of the river segment from the kayak course to the pedestrian bridge downstream of N. Mill Street. Note buried pipeline crossing (light blue) and revetment (orange).

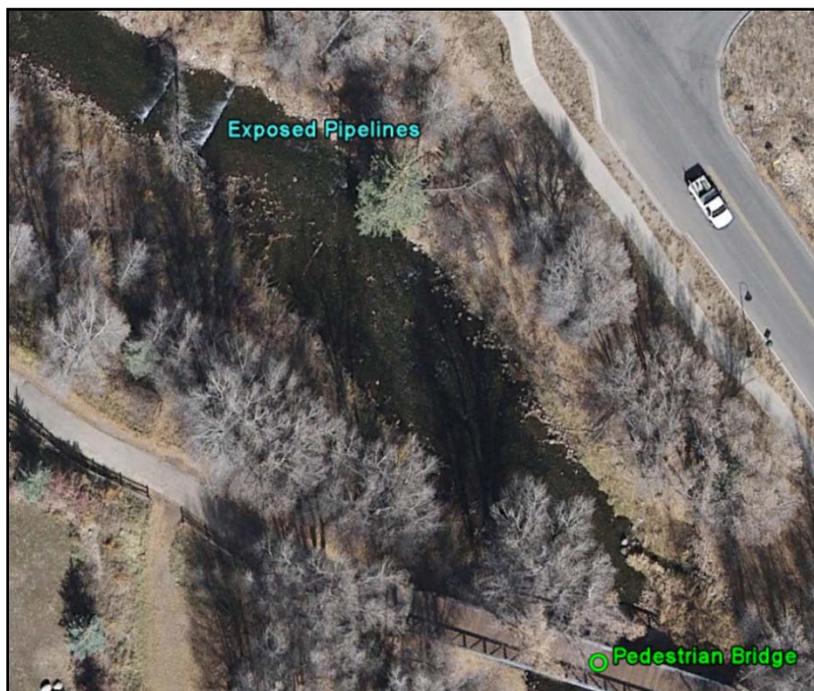
Two exposed pipelines cross the river about 215 feet downstream of the Rio Grande Trail pedestrian bridge located just below the N. Mill Street bridge (**Figure 19**). The two exposed pipes are not included in the City's utility mapping database and are, therefore, assumed to be abandoned. These pipes appear to extend across the entire width of the river and produce less than 1 foot of drop each. It is not known if these pipelines create an impediment to fish passage at low flows.

Figure 19. Aerial view of two exposed pipelines in the river downstream of the Rio Grande Trail pedestrian bridge located just below the N. Mill Street bridge.

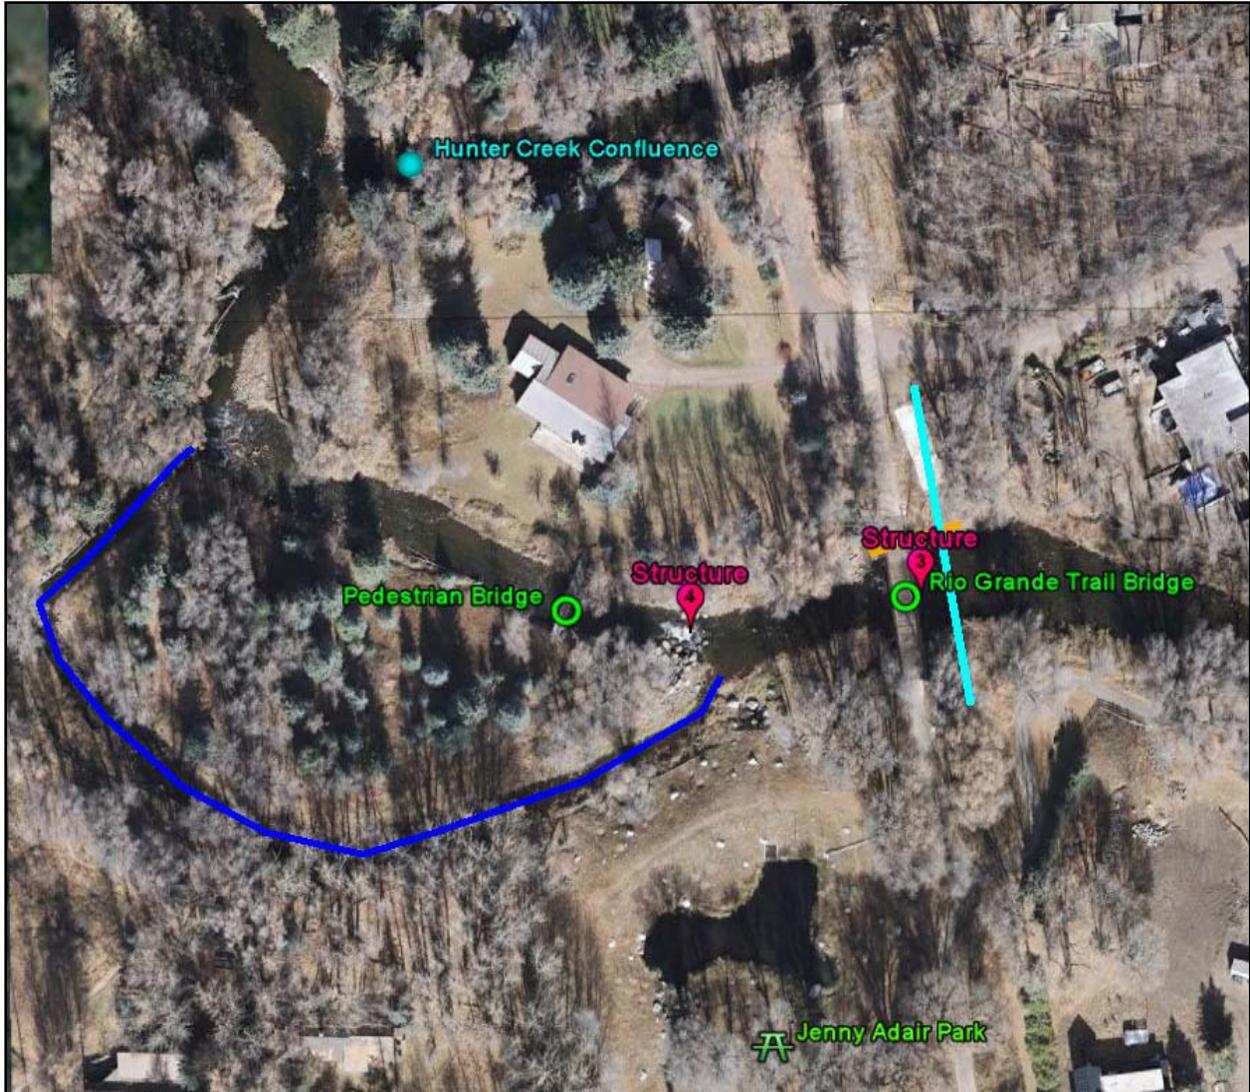
Further downstream in the area of Jenny Adair Park (**Figure 20**), two additional structures were noted, Structures #3 and #4. Structure #3 is located on the upstream side of the Rio Grande Trail pedestrian bridge at Jenny Adair Park and Structure #4 is located about 115 feet downstream of the bridge. As seen in Figure 4, the vertical drop in the profile at both structures is well defined and the apparent backwater flattening of the channel slope upstream of the structures is also well defined

Figure 20. Aerial view of the river segment covering the area around Jenny Adair Park and the Hunter Creek confluence. Note the sewer line crossing (light blue line) and the man-made flow split (dark blue line) associated with Structures #3 and #4, respectively.

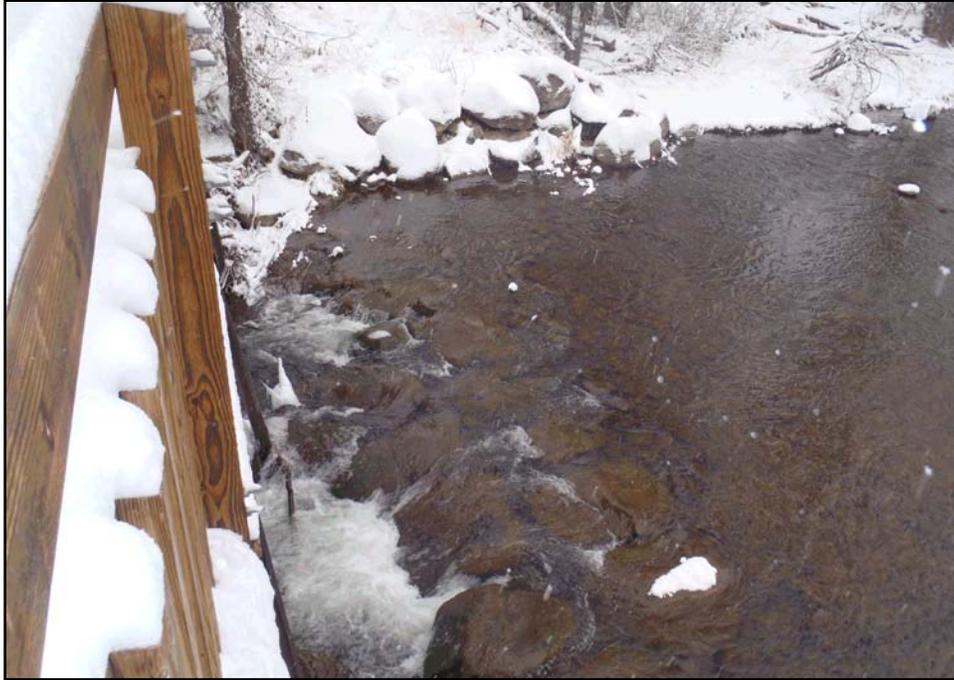
Structure #3 is a man-made boulder drop structure (**Figure 21**) that is associated with a previously exposed sewer line crossing about 15 feet upstream of the structure crest. The structure consists of structural boulders placed across the channel along the upstream face of the pedestrian bridge to protect the sewer line crossing located just upstream. The boulder structure creates about a 2-3 foot vertical drop in the channel gradient immediately below the pedestrian bridge and significant flattening of the upstream channel gradient. Plunging flow over the drop structure has created a significant scour hole along the downstream face of the structure directly under the bridge. Sediment from the scour hole has been deposited immediately downstream of the bridge.

Structure #3 has also induced upstream aggradation, which has fully buried the previously exposed sewer line. Since this structure is located in a high radius bend and as is expected with regard to flow and sediment transport processes in a bend, the bulk of the upstream aggradation has occurred along the left (inner) bank portion of the channel (i.e. point bar) while some slow erosion is occurring along the right (outer) bank upstream of the structure. As seen in Figure 20, typical meander bend processes and the impacts of the structure have created a wider, shallower channel section immediately upstream of the structure. This structure is an impediment to fish passage during low flows and the fine-grained sedimentation that the structure induces for a short distance upstream creates a shallower channel and partially buries available spawning substrate at that location.

Figure 21. View of boulder Structure #3 on the upstream side of the Rio Grande Trail bridge at Jenny Adair Park.

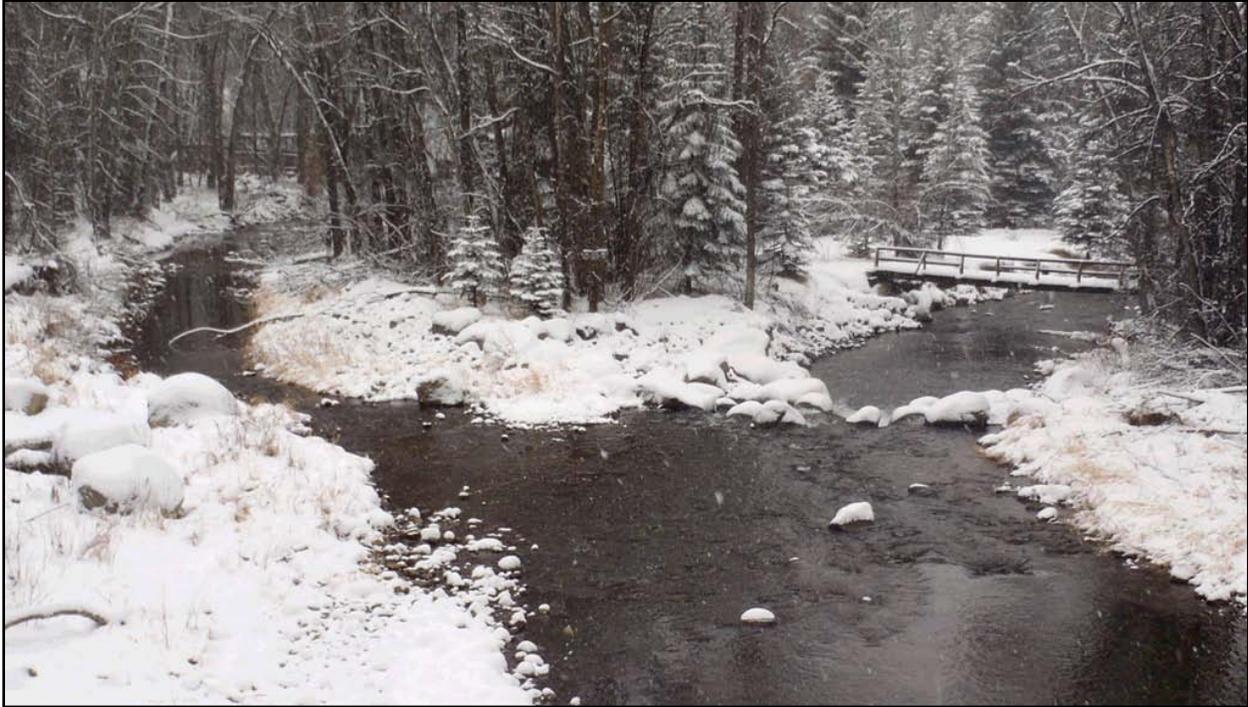
Structure #4 is associated with a man-made split flow channel and island immediately to the south of the structure (see Figure 20). **Figure 22** shows the relationship of the boulder drop structure and the upstream end of the man-made flow split, the resultant island, and the upstream riffle and sedimentation induced by the features. The vertical drop over Structure #4, which is evident in the profile shown in Figure 4, is about 3-4 feet.

It appears that Structure #4 was constructed in conjunction with construction of the man-made split flow channel to the south. The structure appears to be used to divert flows from the main channel of the river into the split flow channel. Both the structure and the split flow channel appear to be associated with the nearby Aspen Center for Environmental Studies. These features are also detrimental to fish passage during low flows. The drop over the boulder structure is too precipitous during low flows to allow fish passage. In addition, an examination of the contour mapping of the area reveals that the upstream end of the split flow channel has a very flat slope, which likely results in either a dry channel or flows too shallow to allow for fish passage during periods of low flow.

Structure #4 also creates a significant flattening of the upstream channel gradient, as indicated by the upstream riffling and sedimentation seen in Figure 22. This riffled and aggraded segment of the river may be sufficiently shallow during low flows to preclude or limit fish passage.

Figure 22. View looking downstream from the pedestrian bridge at Jenny Adair Park showing the boulder drop Structure #4 in the river channel on the right and the narrower, shallow, man-made split flow channel on the left.

We would also recommend the complete removal of Structure #4 at Jenny Adair Park as it appears to serve no other purpose than an aesthetic one. If the split flow channel at this location is, in fact, used by the Aspen Center for Environmental Studies and serves a useful purpose, we would recommend that the boulder grade control structure used to divert flows into the split flow channel still be removed, but that the diversion point be located much further upstream. This can be accomplished by extending the upper end of the split flow channel further upstream to a point where flow can be successfully diverted without requiring a diversion structure while maintaining adequate flow depths and widths as well as fish passage at all flow levels.

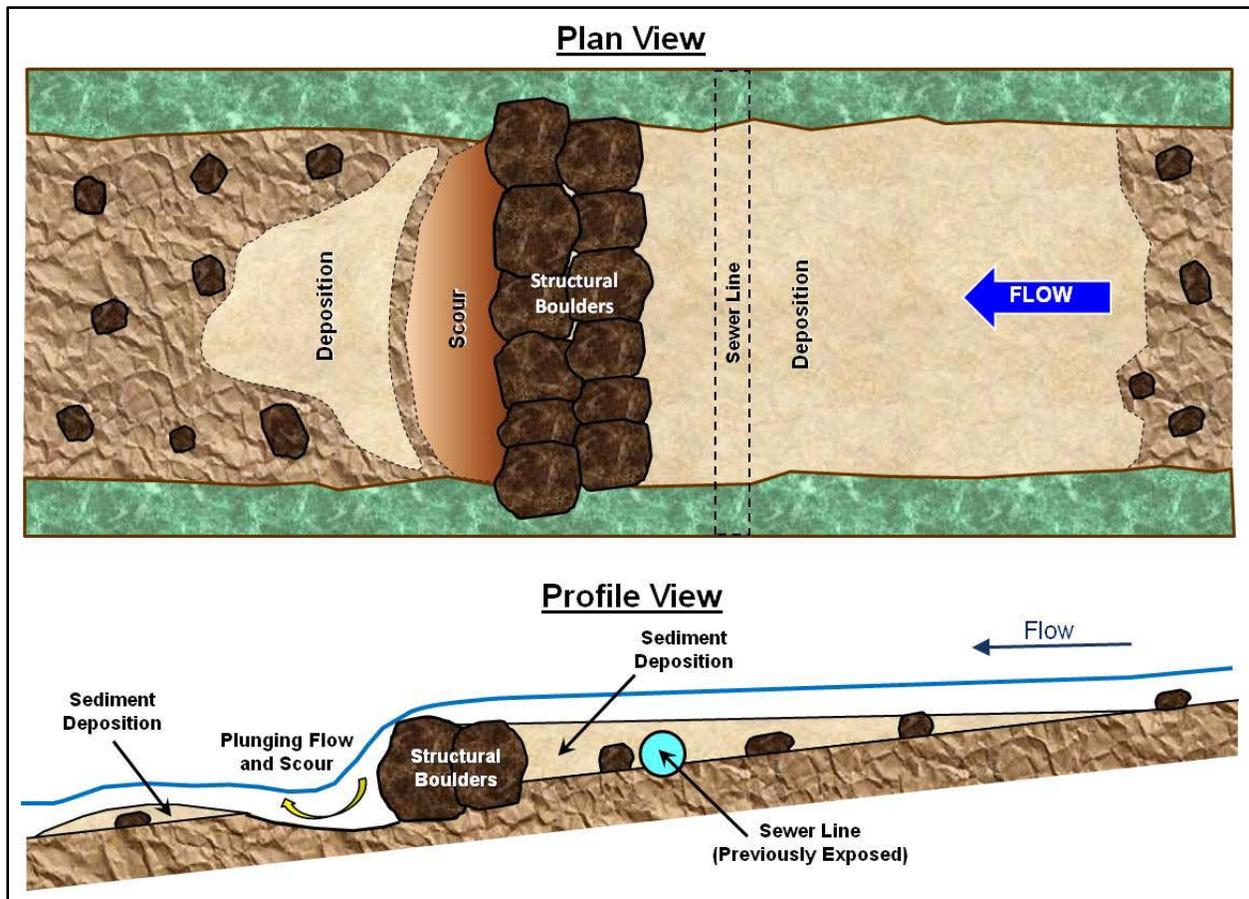
In comparison, **Figure 24** shows the plan and profile view of a typical boulder grade control structure that has been constructed on the river in at least 4 locations. As previously discussed, the boulder structure creates a significant impediment to fish passage during low flows, but may develop a large scour hole and depositional zone downstream that may provide some beneficial habitat. However, the structure also creates a significant flattening of the channel gradient for a short distance upstream, which in turn also induces localized aggradation which reduces the quality of in-stream habitat and spawning substrate at that location. Both the structure and upstream aggradation can also induce or contribute to bank erosion at the ends of the structure as well as immediately upstream of the structure. Bank erosion at the ends of the structure can result in flanking or significant damage to the structures.

Figure 24. Modified flow, scour, and sedimentation patterns created by a boulder grade control structure on a cobble and boulder bed stream.

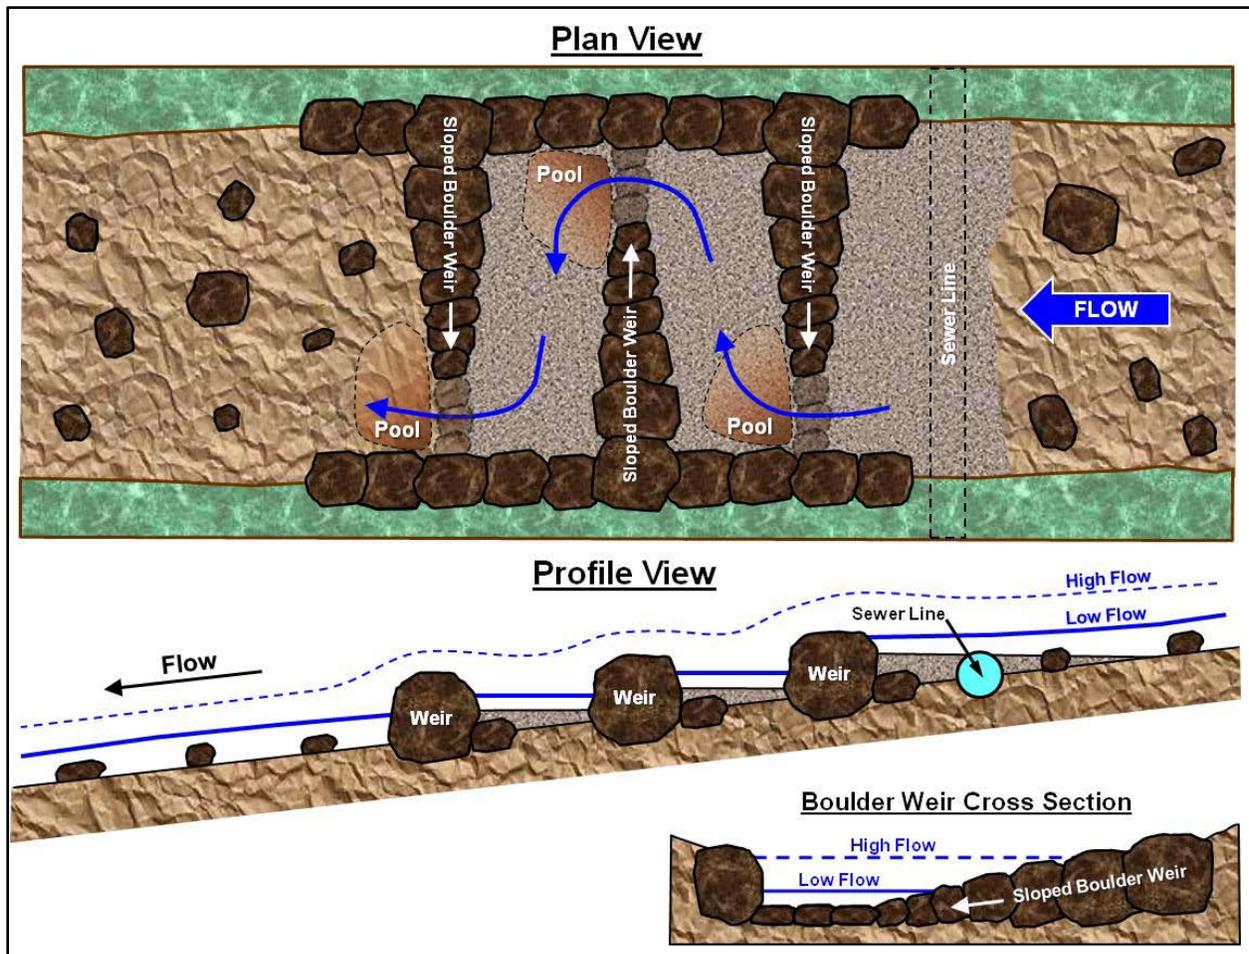
Figure 25. Plan, centerline profile, and cross section views of a typical grade control structure that consists of a series of boulder weirs.

The structures at three of the locations were constructed to protect exposed sewer pipeline crossings. Since it is imperative that these crossing be protected, it would be beneficial to river function to modify the protecting structures such that they still provide maximum protection to the pipelines as well as provide fish passage at all flows. A number of agencies (e.g. Forest Service 2008, Caltrans 2007) provide design guidance for grade control features that also allow for fish passage. For example, one method of grade control consists of a series of rock weirs placed such that flow is allowed to pass over and around the overall structure while maintain unobstructed fish passage as well as grade control. **Figure 25** provides a conceptual plan and profile view of a typical grade control structure using rock weirs.
