**HEALTHY RIVERS AND STREAMS
CITIZENS ADVISORY BOARD
Plaza 1 Meeting Room
530 E Main Street Aspen, CO
Feb 21, 2013 - 4 p.m.**

A Synoptic Approach to Characterizing Low Flow Conditions on the Crystal and Roaring Fork Rivers in the Autumn of 2012.

The Future of Instream Flows in Snowmass Creek

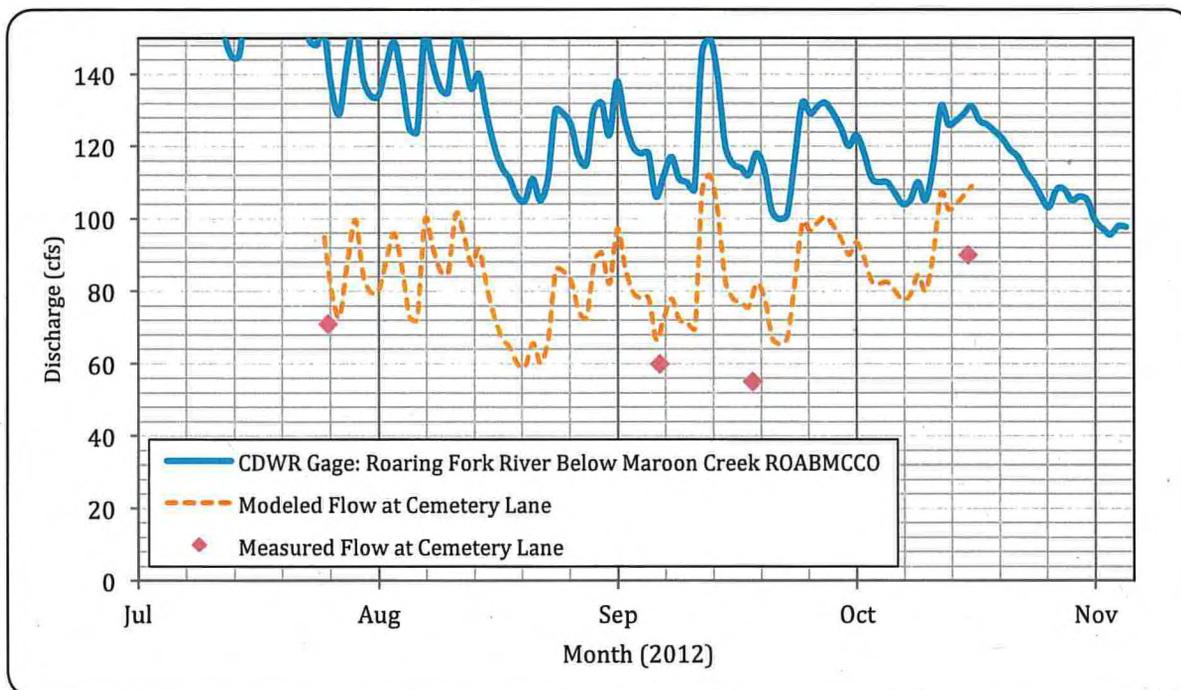
Figure 3. Observed and modeled streamflow at Cemetery Lane. Real-time streamflow data recorded below the confluence with Maroon Creek at a CDWR gauge plotted for reference.

Results show that inclusion of data from Maroon Creek in a subtractive model greatly improves estimates of flow on the Roaring Fork near Cemetery Lane; however, actual streamflows are still overestimated by the model (Table 2). The discrepancies observed between modeled and observed data may arise from the over-simplistic model construction (e.g. some tributary or groundwater inflows/outflows may remain unaccounted for) or may be exaggerated by the sparse nature of the observed data points. The source of the error will be difficult to determine without streamflow data from Maroon Creek of enhanced temporal resolution.

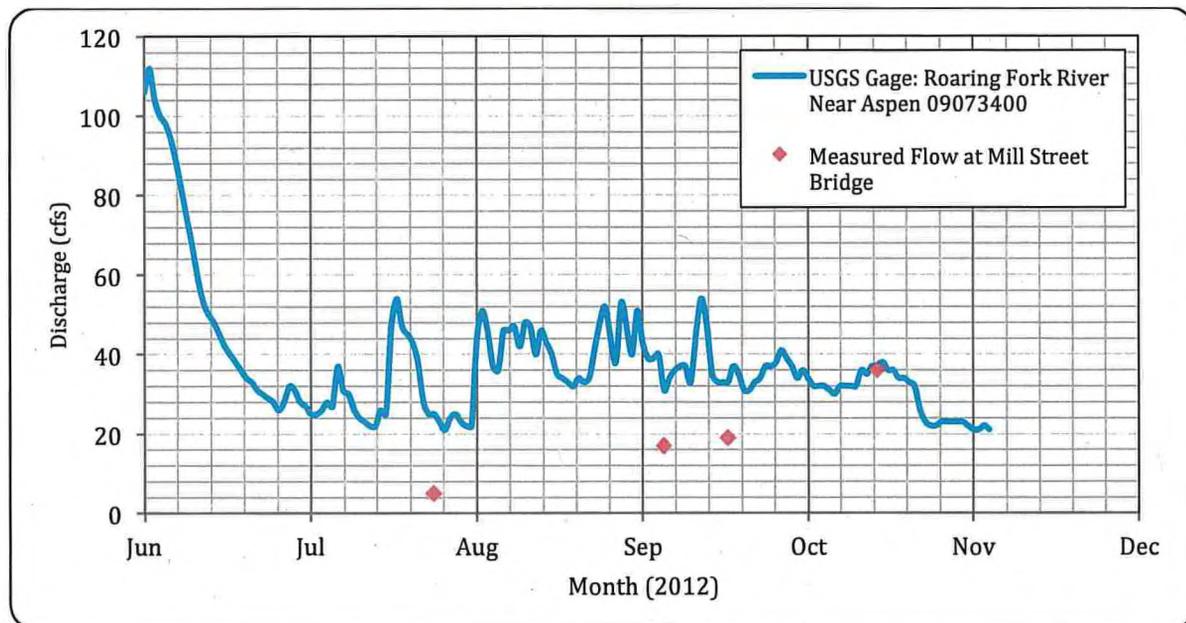
Figure 2. This hydrograph displays the under-estimation of Roaring Fork flows at the Mill Street site during late summer and fall. The last data point records flows after large diversions immediately below the USGS gauge site have ceased for the season. The USGS gauge accurately estimated discharge on the lower river segment on the last data collection date.

The USGS gauge *09073400* is located just upstream of significant local water diversions at the Salvation, Nellie Bird, and Wheeler ditches. Flows measured at the gauge thus overestimate the volume of water flowing through the City of Aspen at any given point in time. The next downstream gauge, *CDWR ROABMCCO*, is sited near the Airport Business Park below the confluence of both Castle and Maroon Creeks. Flow measurements at this site are dominated by these large tributary inputs giving a deceptively robust picture of Roaring Fork River streamflow in the upstream reach. Direct comparison of observed streamflow data collected at Mill Street with the data collected by USGS gauge *09073400* allowed for quantification of the actual discrepancies between the two locations (Table 1, Figure 2).

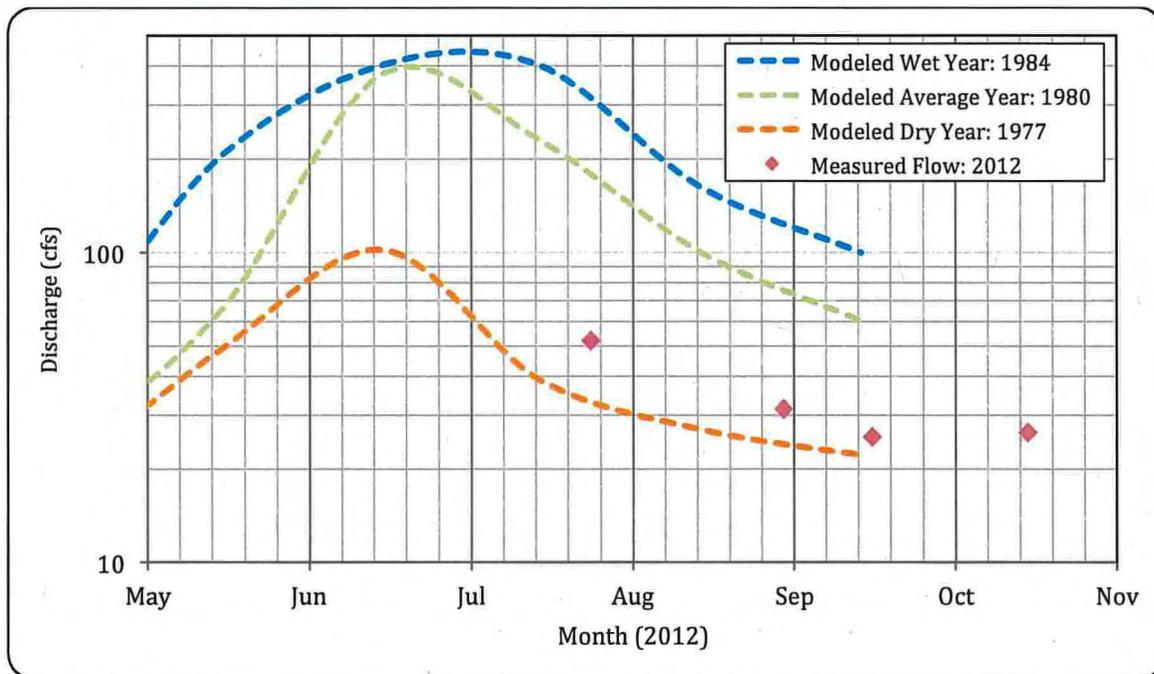
Figure 5. Measured and modeled streamflow for Maroon Creek.

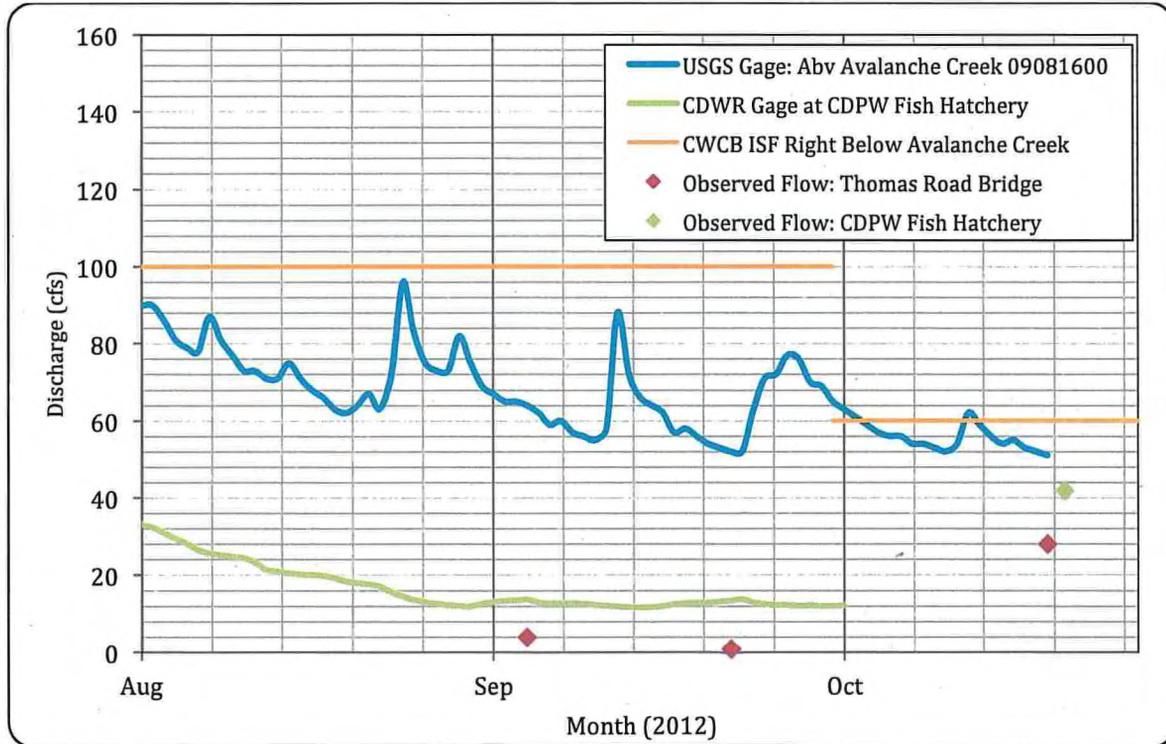
Figure 7. Measured streamflow on the Crystal River at three locations: Avalanche Creek, Thomas Road Bridge and the CDWP Fish Hatchery.

The analysis conducted for this location aimed to identify whether or not the CDWR streamflow gauge at the CDPW Fish Hatchery adequately characterizes conditions on those segments of the Crystal most vulnerable to low summer flows.

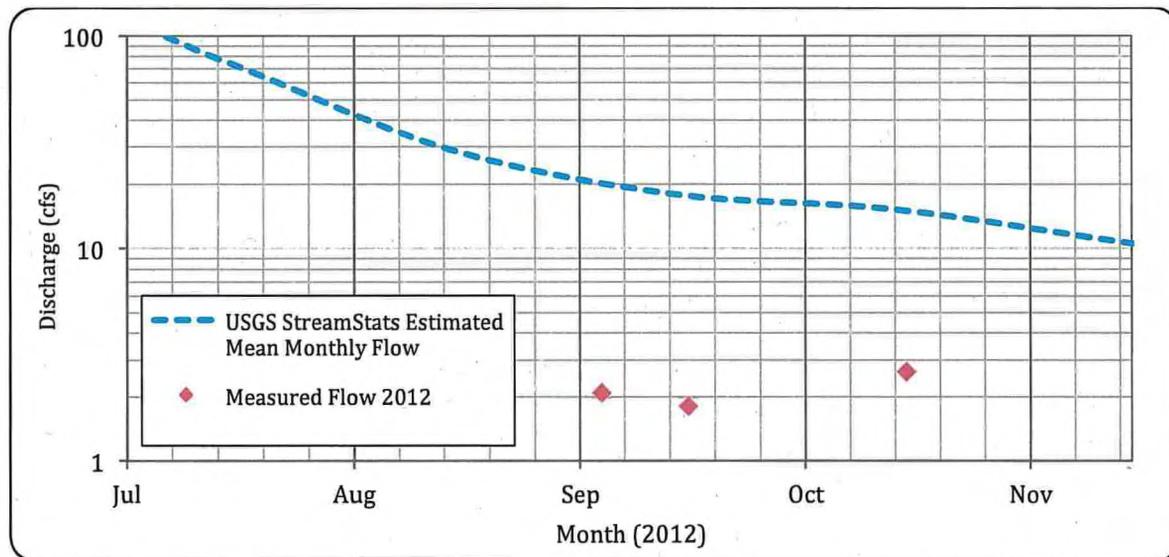
Figure 9. Observed and modeled streamflow for Coal Creek.

generate mathematical relationships for estimating flow parameters in similar, ungauged locations. StreamStats generated three statistics related to modeled low flow conditions at the drainage point corresponding with the measurement location used to collect the 2012 data. The generated statistics include the M7D10Y, Q9, and Q10. M7D10Y represented the 7 day average low flow corresponding to an event with a one in ten year return interval. The Q9 and Q10 statistics estimated the mean monthly flows for September and October. While 2012 flows were well below the estimated mean produced by StreamStats (which has a significant error range), they compared reasonably well to the 10 year low flow estimate of 1.26 cfs.

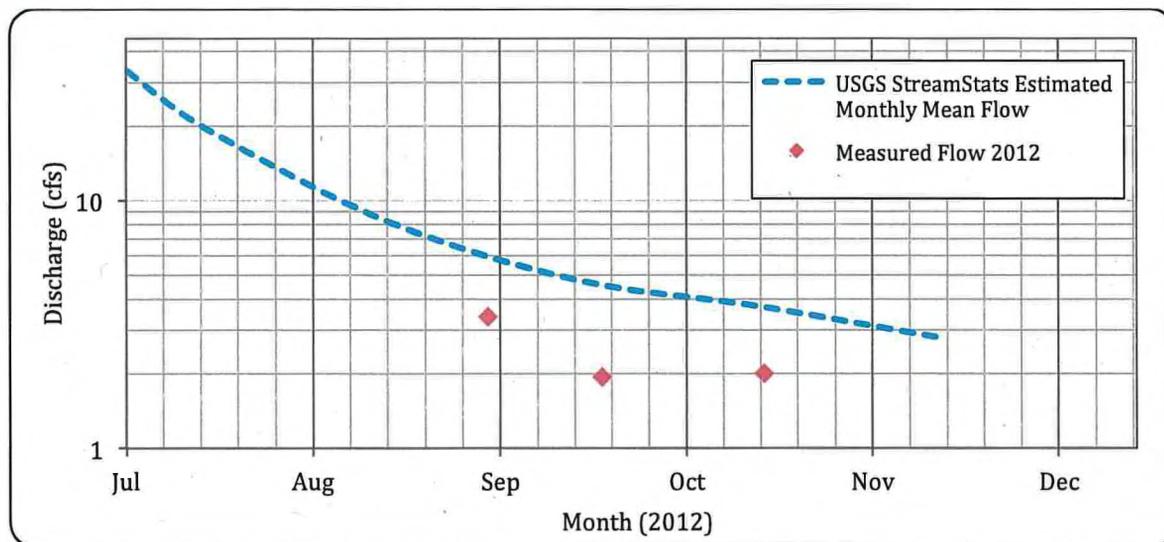
Figure 11. Observed and modeled streamflow for Brush Creek.

regression models like StreamStats have limited utility in watersheds like Brush Creek, due to the confounding effects of human ‘plumbing’ of the stream and river systems. StreamStats generated three statistics related to modeled low flow conditions at the drainage point corresponding to the measurement location used to collect the 2012 data. The generated statistics included the M7D10Y, Q9, and Q10. The M7D10Y statistic represents the 7 day average low flow corresponding to an event with a one in ten year return interval. The Q9 and Q10 statistics estimated the mean monthly flows for September and October. Measured flows compared reasonably well to the estimated monthly mean streamflows, although flows were consistently over-estimated by the model. Observed streamflows were much greater than the M7D10Y statistic (i.e. the estimated 10 year low flow) of 0.27 cfs. Possible explanations for this result include both the large model estimation error and the fact that Brush Creek receives trans-basin water augmentation which elevates streamflows above conditions expected in drought year.

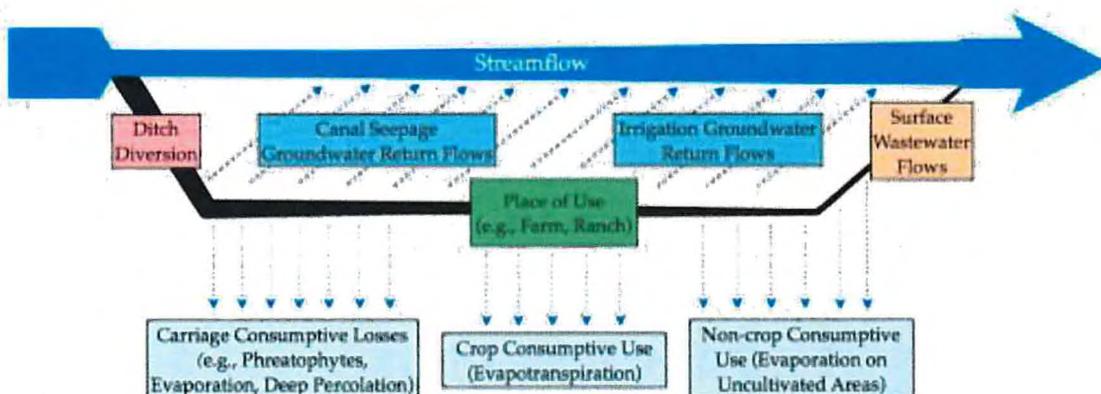
Figure 2. Conceptual model of the water balance on rivers subjected to water diversions for irrigation. The thickness of the blue arrow is proportional to streamflow in the river channel. The thickness of the black line is proportional to the rate of flow in the diversion channel (adapted from Driscoll, 2012).

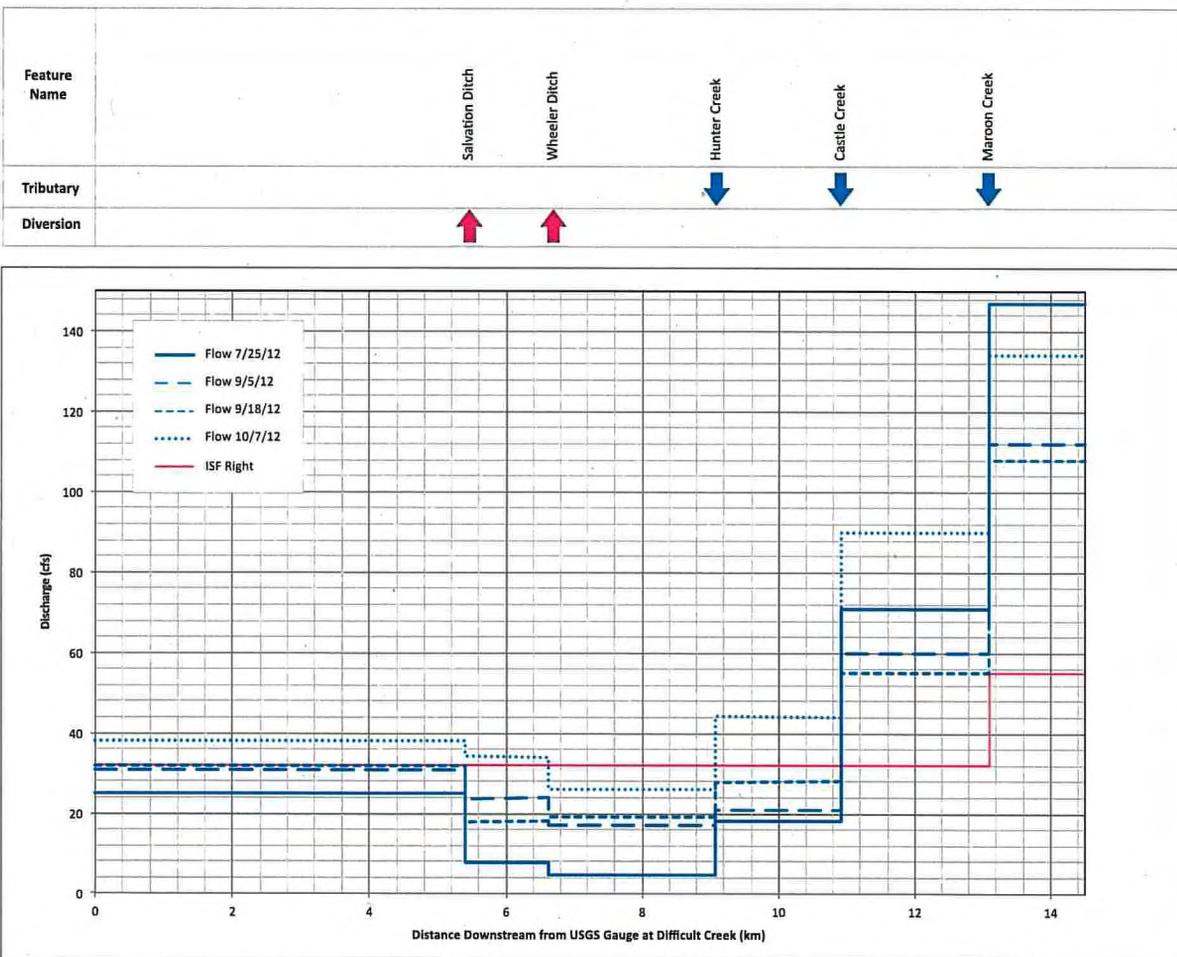
Figure 3. Observed flows on the Roaring Fork River during the study period. Profile confirms that the most de-watered section of the river extends from below the Salvation and Wheeler ditches to the confluence with Castle Creek. This figure plots longitudinal changes in streamflow under the assumption that changes in discharge occur at discrete locations where the river experiences tributary inflows or diversions.

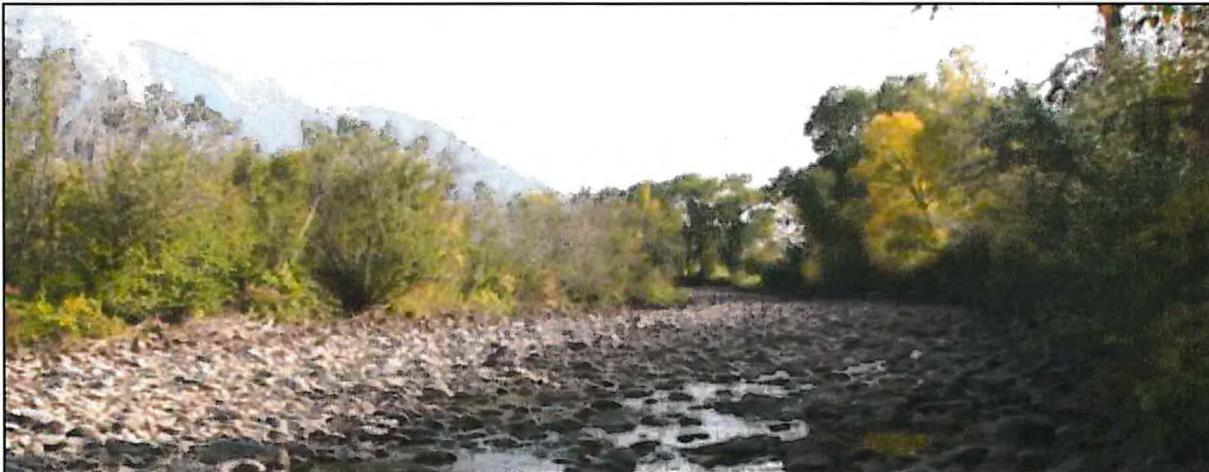
The Crystal River above Thomas Road observed on 9/24/2012. This extremely low flow condition effectively eliminated upstream-downstream hydrological (and ecological) connectivity.

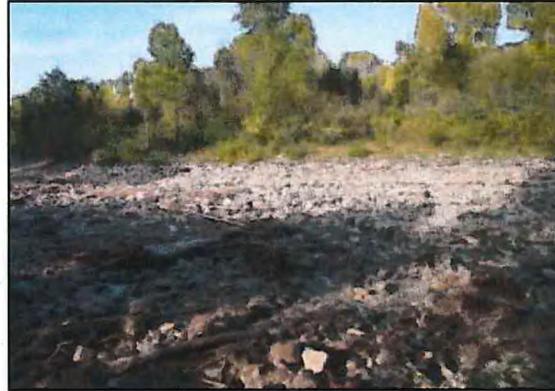
The Crystal River completely de-watered at the end of September near the Garfield-Pitkin County line.

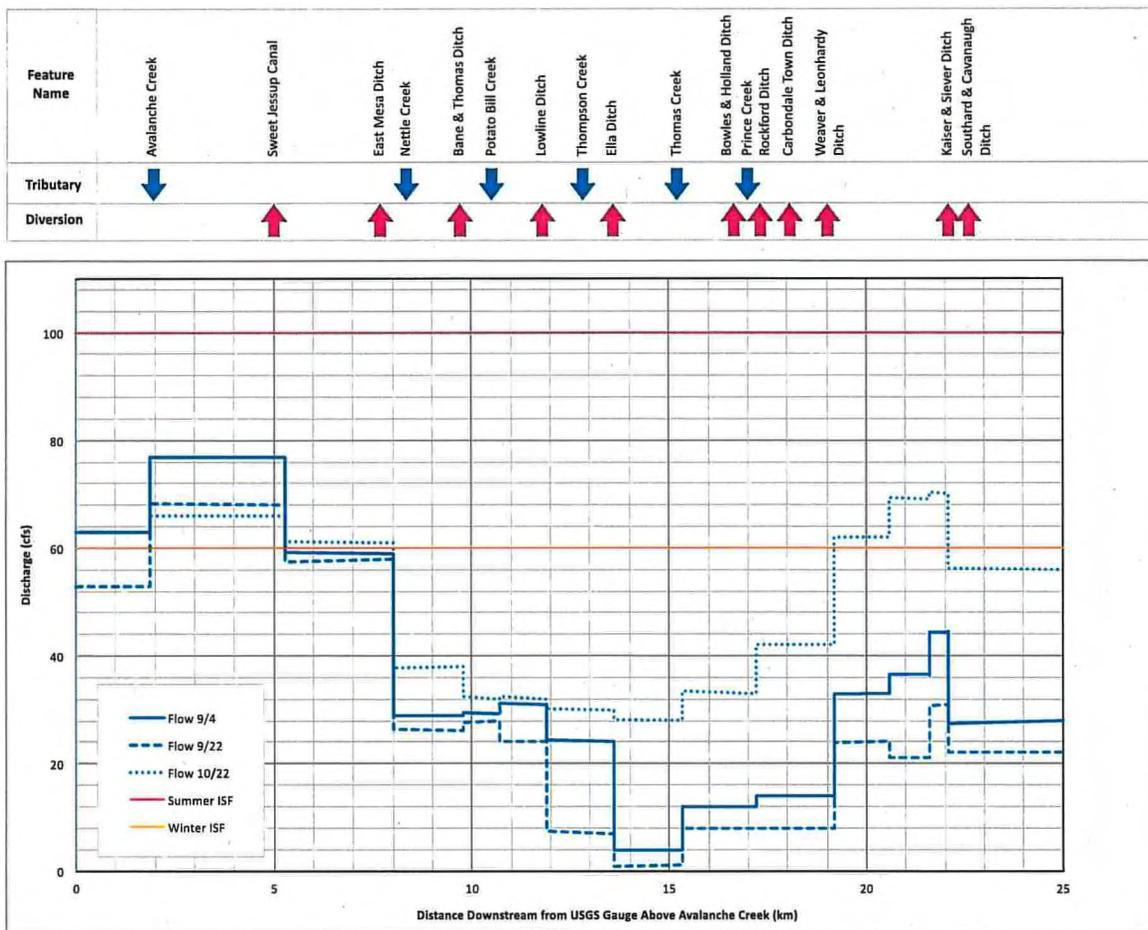
Figure 4. Observed flows on the Crystal River during the study period. Profile confirms that the most de-watered section of the river exists near Thomas Road. This figure plots longitudinal changes in streamflow under the assumption that changes in discharge occur at discrete locations where the river experiences tributary inflows or diversions.

An intricate system of diversion ditches and persistent water use needs produced a complex but persistent pattern of longitudinal streamflow on the Crystal River (Figure 4). The two September sample collection dates coincided with heavy irrigation use pressure and little thunderstorm activity. Flows ranged from 77 cfs below Avalanche Creek in early September to a low of 1 cfs at Thomas Road in mid-September (Table 5). The upper section of the study reach was relatively unaffected by diversions and consistently produced the highest streamflow. Diversion activity below Avalanche Creek coincided with large reductions in observed streamflow on all three sampling dates.

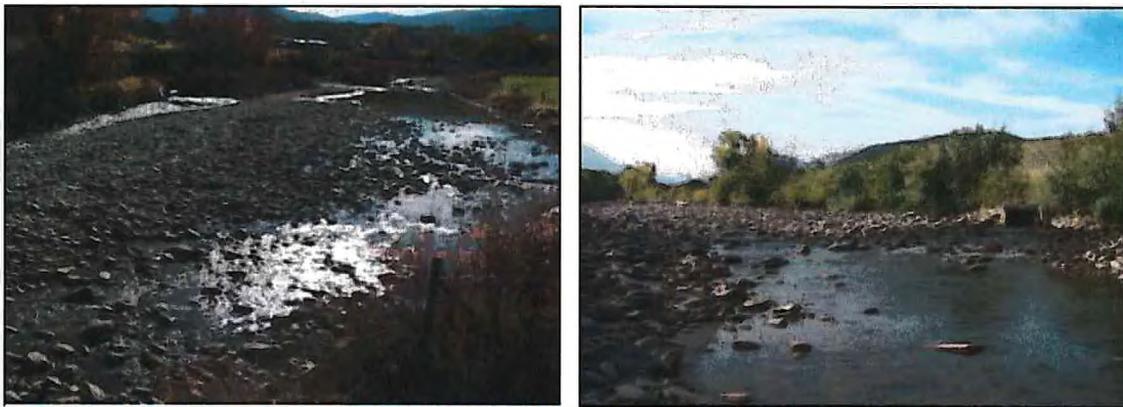
The Crystal River upstream of the Town of Carbondale. Return flows on the west side of the river and at the Carbondale ditch provide a cooling inflow to dewatered sections of the Crystal which are subject to rapid heat gain.

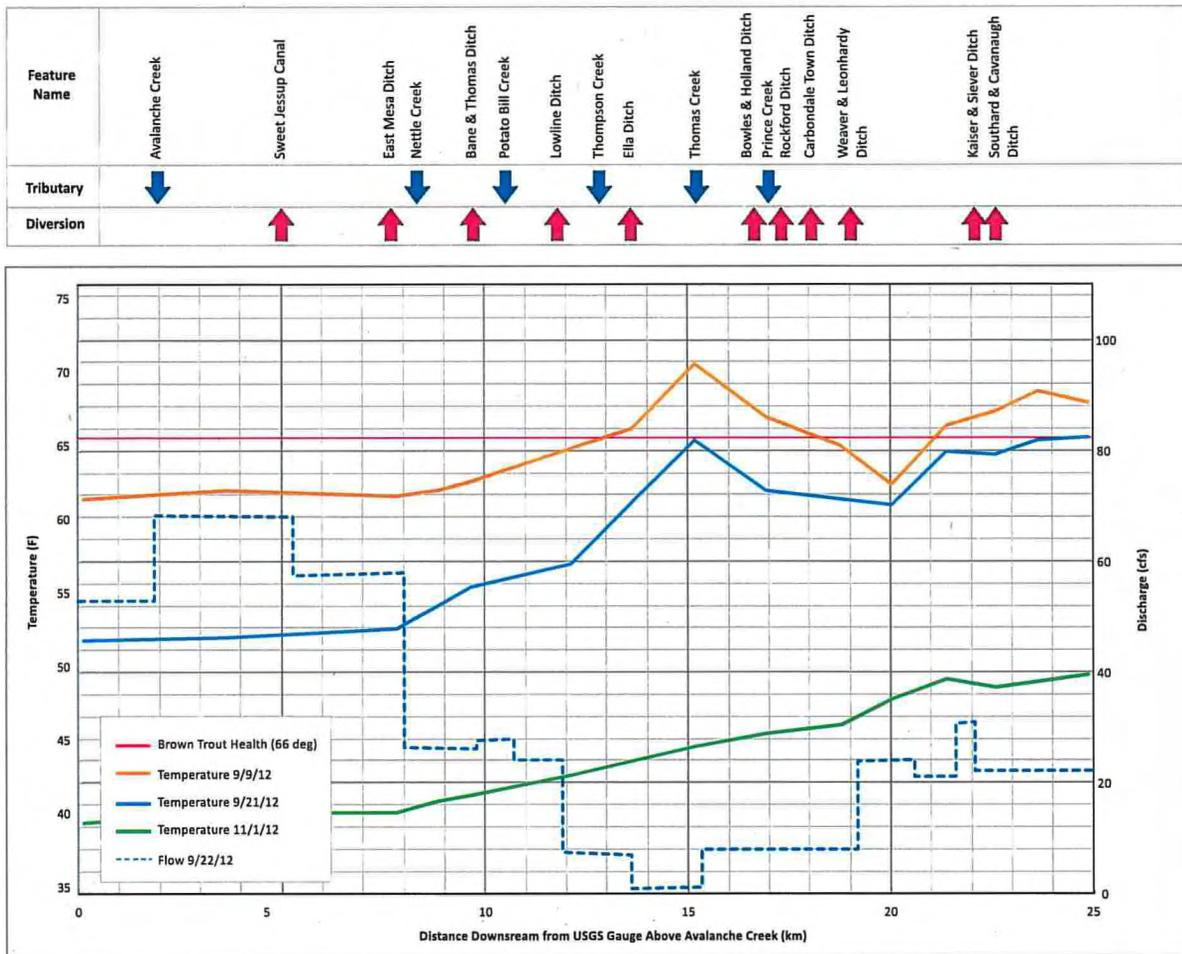
Figure 12. Observed temperatures on the Crystal River. Temperatures rise rapidly as flow decreases, peaking in the area near Thomas Road.

The CDPW temperature threshold was exceeded at two locations in early September on the Crystal River. In the most flow-depleted segments (between Thompson and Thomas creeks), observed temperatures in the Crystal River were relatively high during both September sampling dates. The rapid rate at which the river absorbed heat at these locations is reflected in the relatively steep upward slopes of the temperature profiles in the segment (Figure 12). As return flows, tributaries, and assumed groundwater influxes contributed to streamflow below Thomas Creek, water temperatures began to decline. During the final round of post-irrigation season observations, the sharp temperature spike previously observed near Thomas Road did not persist. Citizens participating in the Roaring Fork Conservancy's *Hot Spots for Trout* volunteer monitoring program (www.roaringfork.org) recorded multiple observations of temperatures above the recommended standard of 66° F at the Fish Hatchery and Colorado Rocky Mountain School (Appendix B). The highest temperatures were recorded by RFC at these two locations on the Crystal River were as follows: 68°F on August 12 at 6:00PM at the Fish Hatchery and 72.5°F on July 12 at 2:00 PM at the CRMS Bridge.

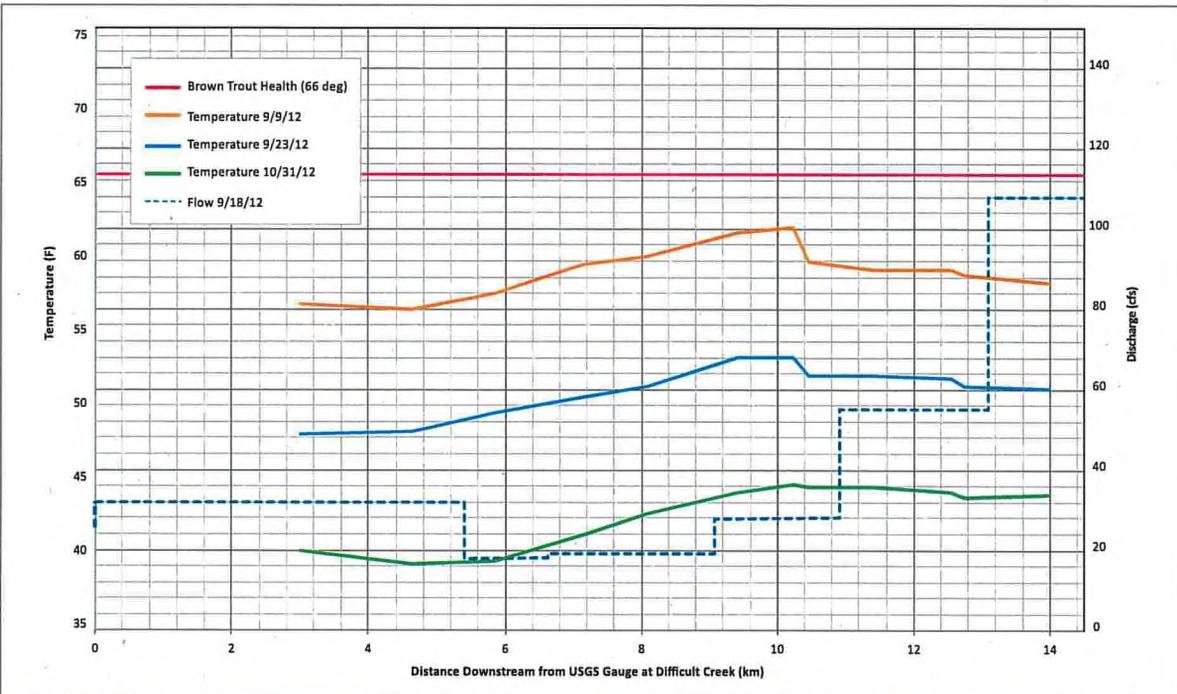
Figure 13. Observed temperatures on the Roaring Fork River near the City of Aspen. Low flow conditions coincide with relatively rapid heat gain.

The Roaring Fork study reach did not reach temperature levels stressful to fish during any of the three sampling events (Figure 13). This can be largely attributed to this reach’s location at a higher elevation in the watershed. However, prior to collection of data for this study, citizens participating in the Roaring Fork Conservancy’s *Hot Spots for Trout* volunteer monitoring program (www.roaringfork.org) found temperatures at or above the recommended standard of 66°F at the Hopkins Street Footbridge, a flow-depleted section of the study reach upstream of Mill Street (Appendix B). These observations were made on 6/30/2012, 7/10/2012, and 7/26/2012. Sections of the river experiencing the lowest flows show the most rapid heat gain as displayed by the slope of the longitudinal temperature profile. Tributary inflows from Castle Creek and Maroon Creek had a visible cooling effect on streamflow in the Roaring Fork River.

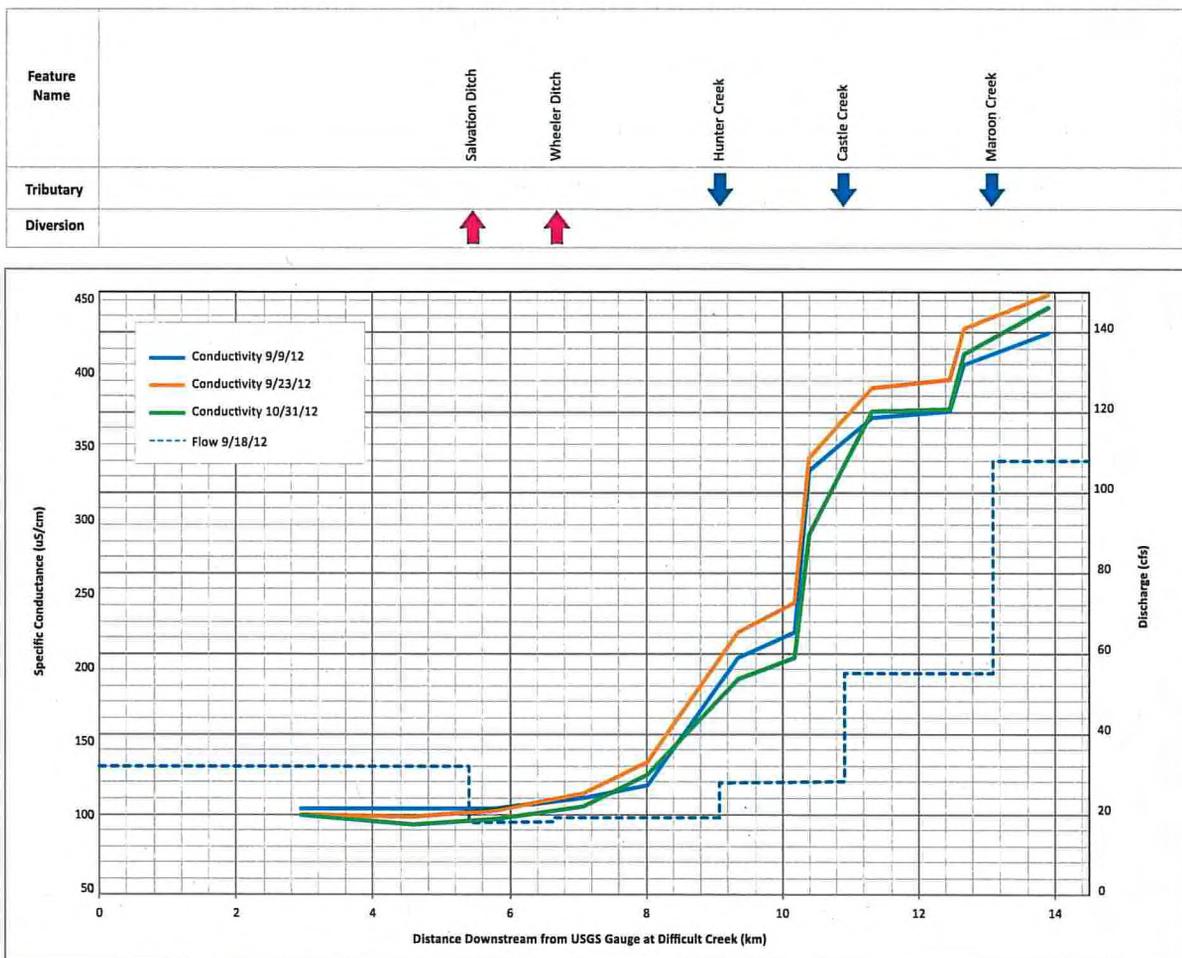
Figure 14. Observed specific conductance profiles on the Roaring Fork River.

Water in the upper Roaring Fork River displayed relatively low specific conductance. Conductance increased with downstream distance as the river flowed through the City of Aspen (Figure 14). The observed increase may result from diffuse urban runoff, stormwater drains, and irrigation return flows. A sharp increase in conductance observed below the confluences with Castle Creek and Maroon Creek, suggests that these two tributaries carry relatively large TDS loads. The water quality characteristics of Maroon and Castle creeks produced disproportionately large impacts on the overall water quality characteristics of the Roaring Fork River because the streamflow contributions from the two creeks represented a large fraction of the total streamflow in the Roaring Fork below the City of Aspen. Elevated TDS concentrations in these tributary streams is likely related to natural geological weathering as both tributary watersheds are relatively undeveloped.

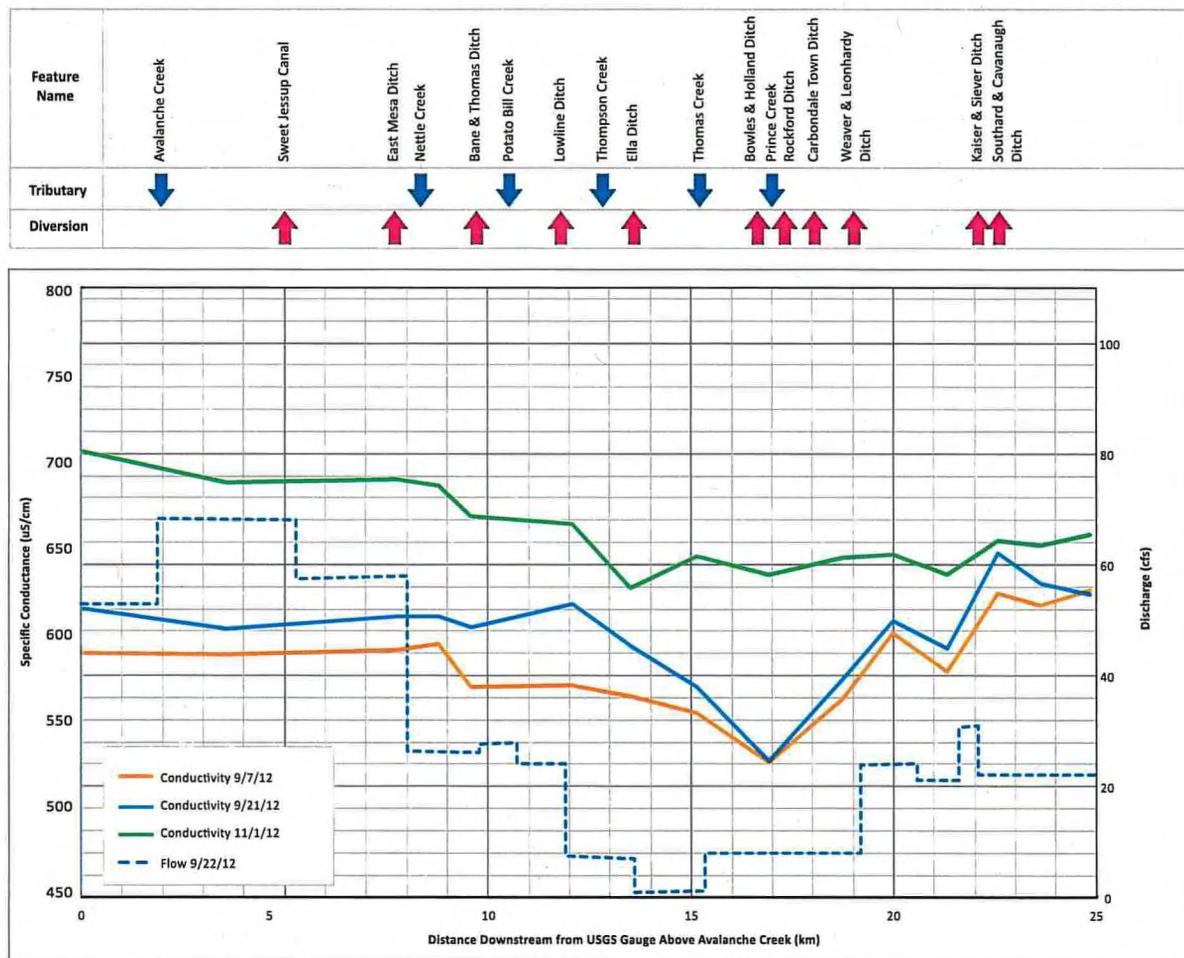
Figure 15. Observed specific conductance profile on the Crystal River.

Specific conductance remained relatively constant in the upper section of the Crystal River study reach, decreasing slowly through the most dewatered section on the reach (Figure 15). This pattern may be explained by the possibility that a large fraction of the streamflow in the Crystal River below Thompson Creek is contributed from tributaries or groundwater from the alluvial aquifer exhibiting relatively low specific conductance values. Conductance rose lower on the river where flows were likely affected by both groundwater influxes and irrigation diversion return flows. A seasonal trend was evident from early September to later in the fall. Specific conductance increased through September to its highest levels in late October. Specific conductance is generally inversely related to streamflow (e.g. dissolved solids are more concentrated when streamflow is low). As the amount of water diverted from the Crystal River decreased in October, streamflows in the river channel increased at each observation location. Surprisingly, specific conductance also increased—an unexpected trend. Without more observations to characterize inter-annual and inter-seasonal variability, it is difficult to make many conclusions regarding this pattern. However, an early snowstorm and subsequent runoff from snowmelt—which is expected to exhibit elevated conductance values—may have played an important role.

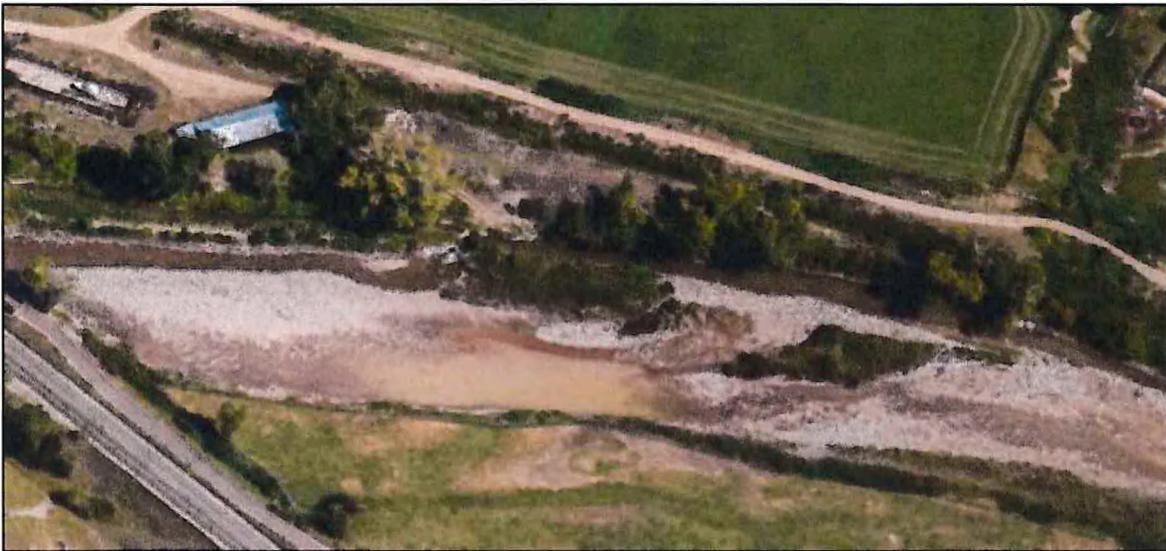
Dewatered section of the Crystal River above the Town of Carbondale. Without much flow, these segments experienced rapid heat gain during late summer and fall days.
