Final Report
Evaluation of River Health
Roaring Fork River near Aspen, Colorado
Contract # 114-2010

Executive Summary

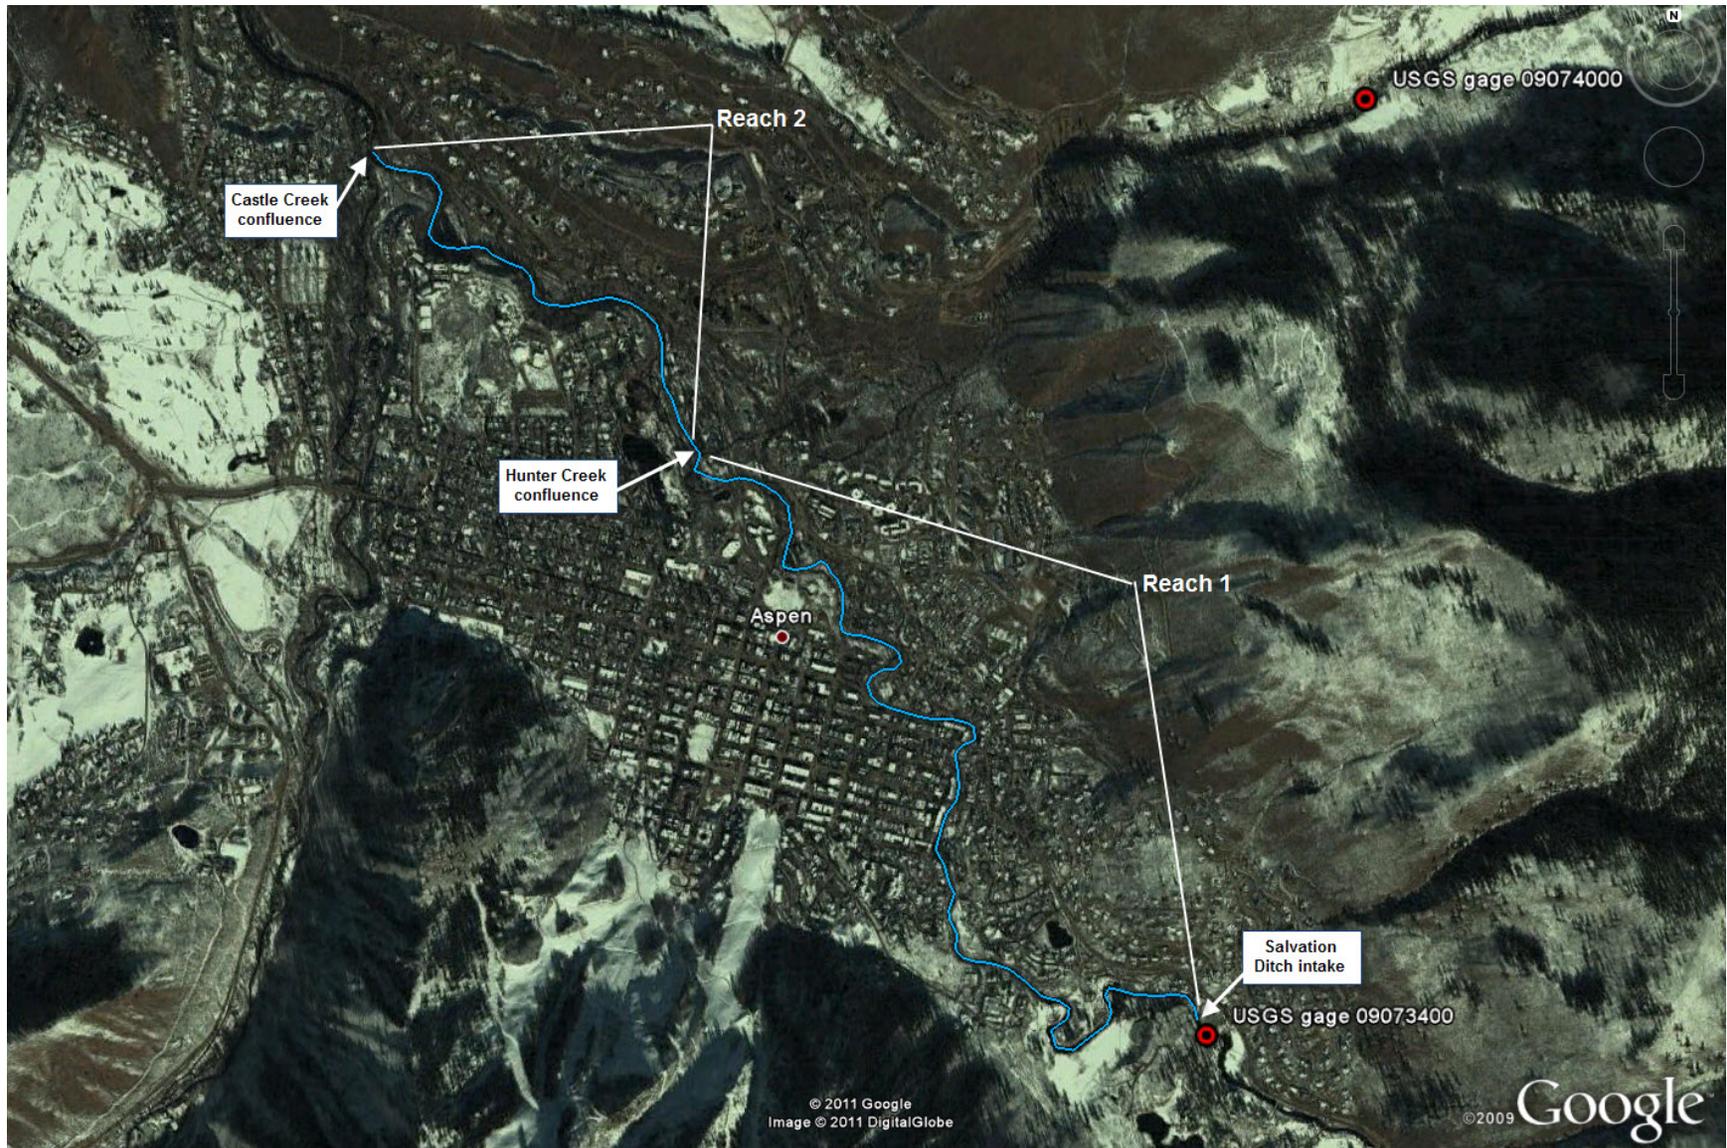
Figure 1. Study reach and hydrologic study reaches of the Roaring Fork River between the Salvation Ditch diversion and the confluence with Castle Creek.

The study area is the Roaring Fork River between the Salvation Ditch diversion and the confluence of Castle Creek, a distance of approximately 3.2 miles. The urban environment of the city of Aspen surrounds the majority of the river within this reach (Figure 1). Site

The reach of the Roaring Fork River that was examined as part of this assessment extends from the confluence of Castle Creek upstream to the Salvation Canal diversion structure, a distance of approximately 3.2 river miles (**Figure 1**). However, the focus of this assessment was on the a portion of the reach starting from just below the Rio Grande Trail pedestrian bridge at Jenny Adair Park to just upstream of the Neale Avenue crossing (Florence and Fred Gilden Bridge) and Prockter Park (**Figure 2**). Within this subreach, there are a series of man-made structures, also shown in Figure 2, that are problematic with regard to degraded fish habitat, obstructed low flow fish passage, and sediment transport.

highly constricted (see Figure 1), which may have contributed to the flat, meandering section of the river immediately upstream. Upstream, the Salvation Canal diversion structure and Stillwater Drive are situated on coarse-grained glacial moraine deposits. The steeper segments of the river downstream of the Aspen Club are situated on glacial outwash deposits. Thus, relict coarse-grained glacial material is the primary sediment found in the banks and bed of the river. Immediately downstream of the Aspen Club to about Neale Avenue, the river flows over and is slowly downcutting through older glacial outwash deposits. Below Neale Avenue, the river flows over younger glacial outwash deposits. In places along the lower portion of the reach, the river is bound by and flows between relict glaciofluvial terraces.

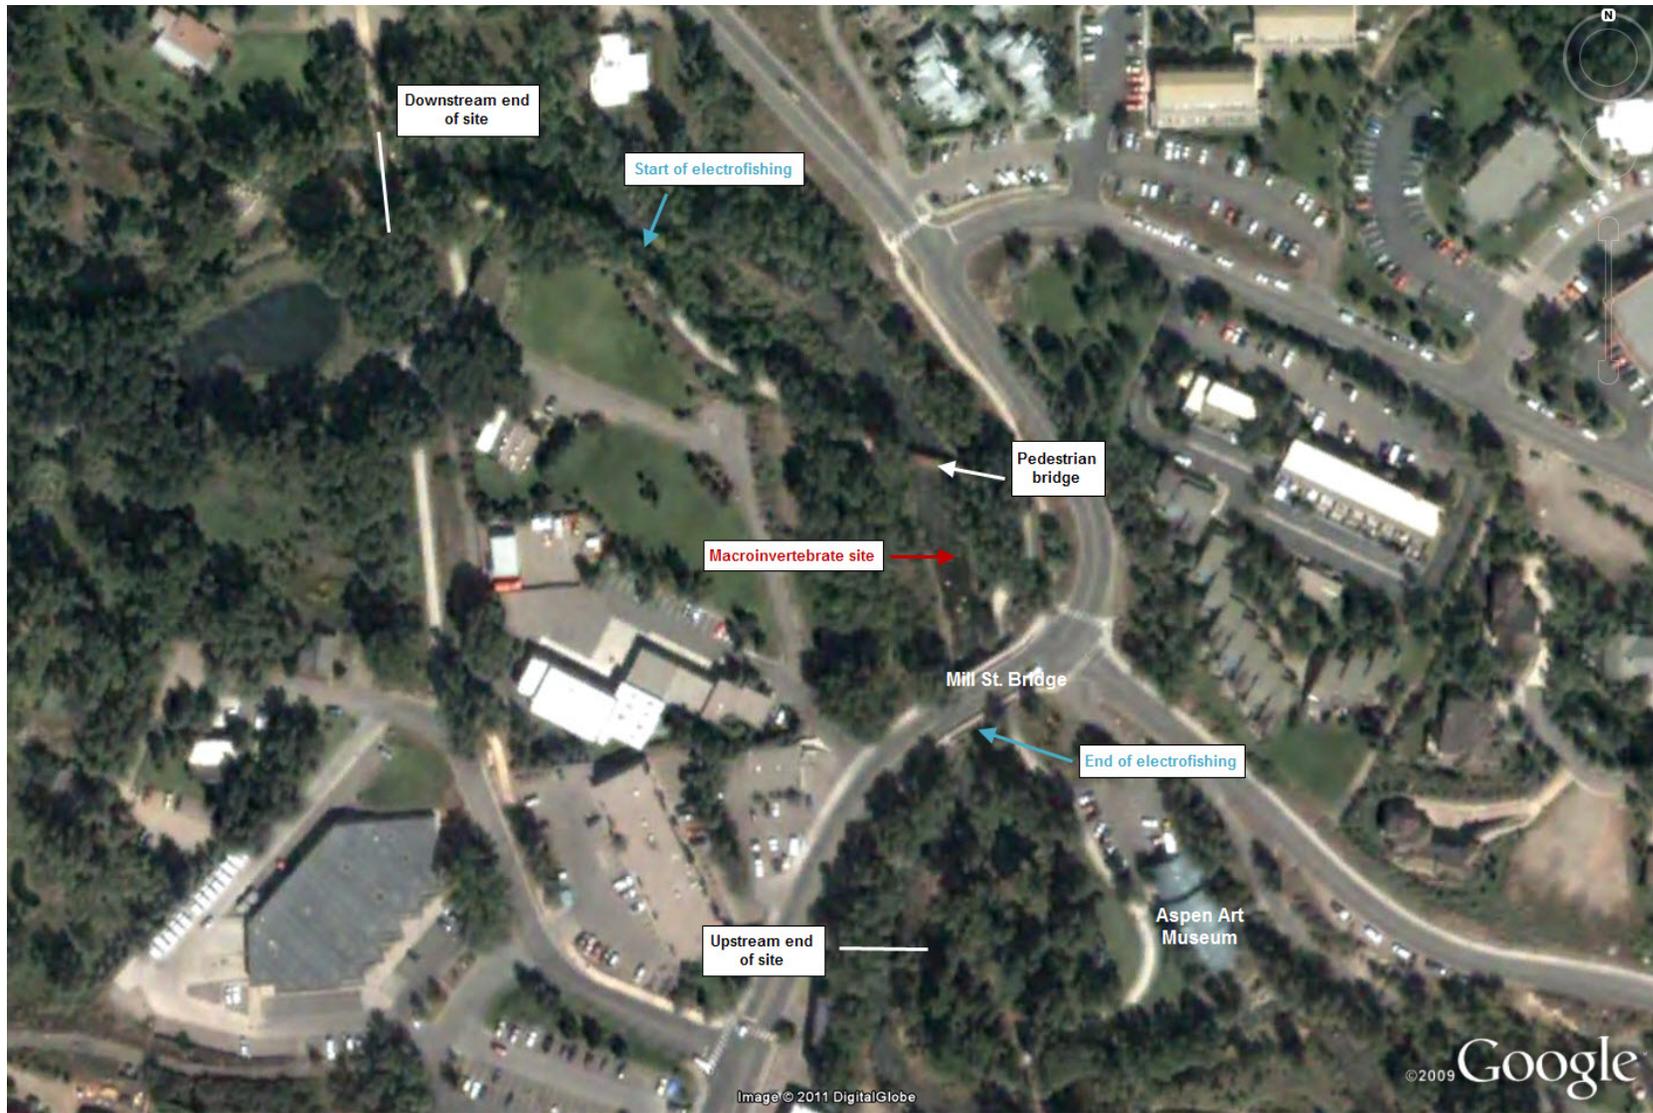
Figure 2. Map of the River2D study site on the Roaring Fork River.

reconnaissance for instream habitat modeling and fish and invertebrate sampling took place on August 10, 2010. We determined from the site visit that the river at the Mill Street bridge was representative of the 3.2-mile reach. The study site is 1090 feet long (0.20 miles or 330 meters) (Figure 2). The downstream end of the site occurs at the Rio Grande Trail pedestrian bridge at Jenny Adair Park and the upstream end of the site is just west of the Aspen Art Museum. Photos of the site can be found in Appendix D.

The fish community was sampled via electrofishing. Two backpack electrofishers with three anodes were used to collect fish. The total length of stream sampled was 690 feet and was within the same reach modeled for instream habitat (Figure 2). Two passes for fish removal were made at the site and a population estimate could be calculated. All captured fish were identified, weighed, measured, checked for external parasites, and returned to the stream. Fish

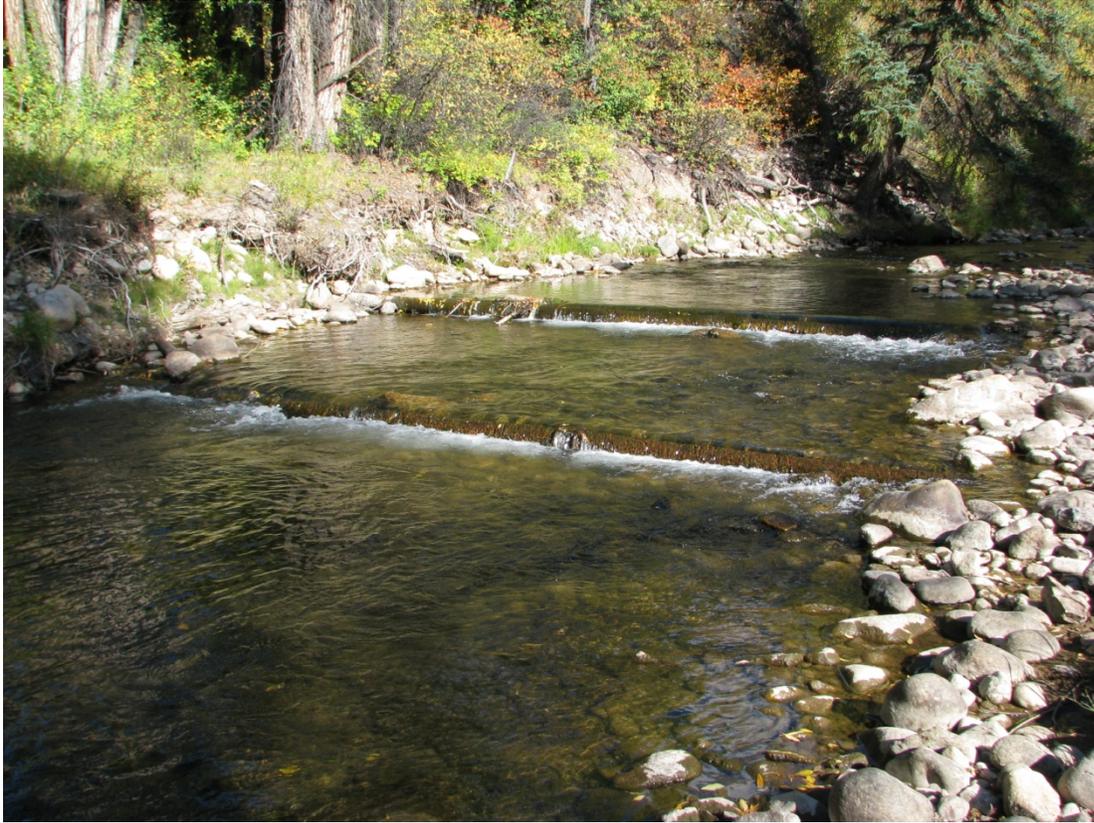
Figure 21. Exposed pipelines at low flow (17.5 cfs).

At this time, we would recommend that the Healthy Rivers and Streams Program, in cooperation with the City of Aspen and Pitkin County reconstruct the boulder structures using a series of weirs. We would also recommend the complete removal of the structure at Jenny Adair Park as it appears to serve no other purpose than an aesthetic one. If the split flow channel at this location is, in fact, used by the Aspen Center for Environmental Studies and serves a useful purpose, we would recommend that the boulder grade control structure used to divert flows into the split flow channel still be removed, but that the diversion point be located much further upstream. This can be accomplished by extending the upper end of the split flow channel further upstream to a point where flow can be successfully diverted without requiring a diversion structure while maintaining adequate flow depths and widths as well as fish passage at all flow levels. We also recommend the removal of the pipelines crossing the river downstream of Mill Street. The pipelines create an impediment to the natural flow lines and could trap floating debris at higher flows. These pipelines appear to be abandoned and if so, should be removed.

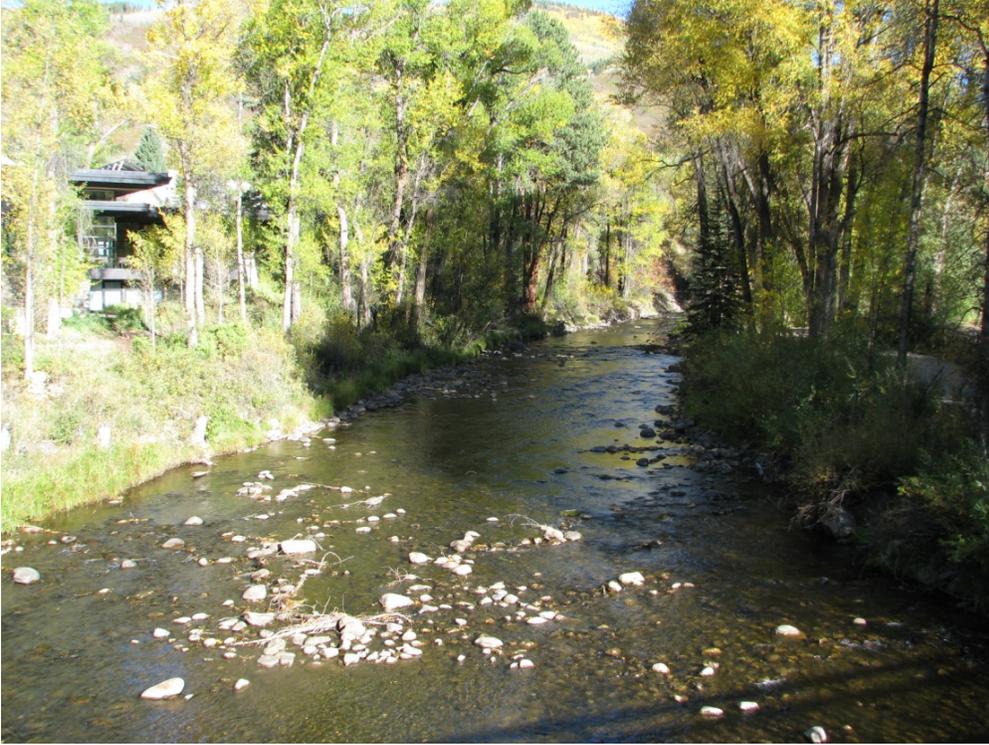
Figure D-1. Downstream end of the site looking upstream, 17.5 cfs (low flow), September 28, 2010.

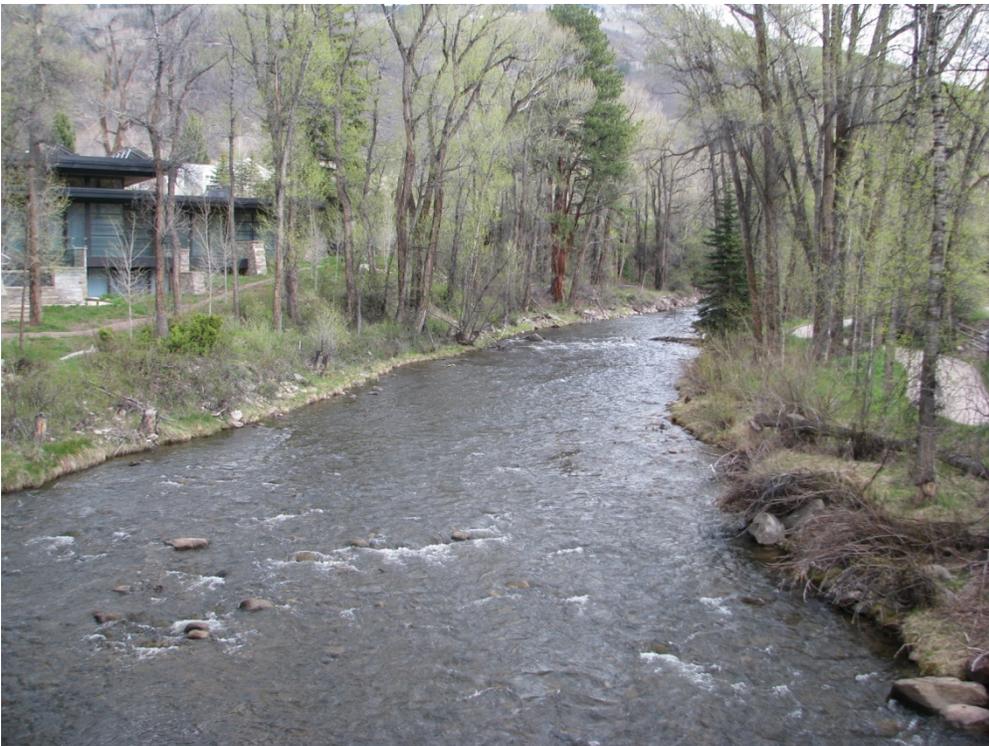
Figure D-2. Downstream end of the site looking upstream, 98 cfs (mid flow), May 23, 2011.

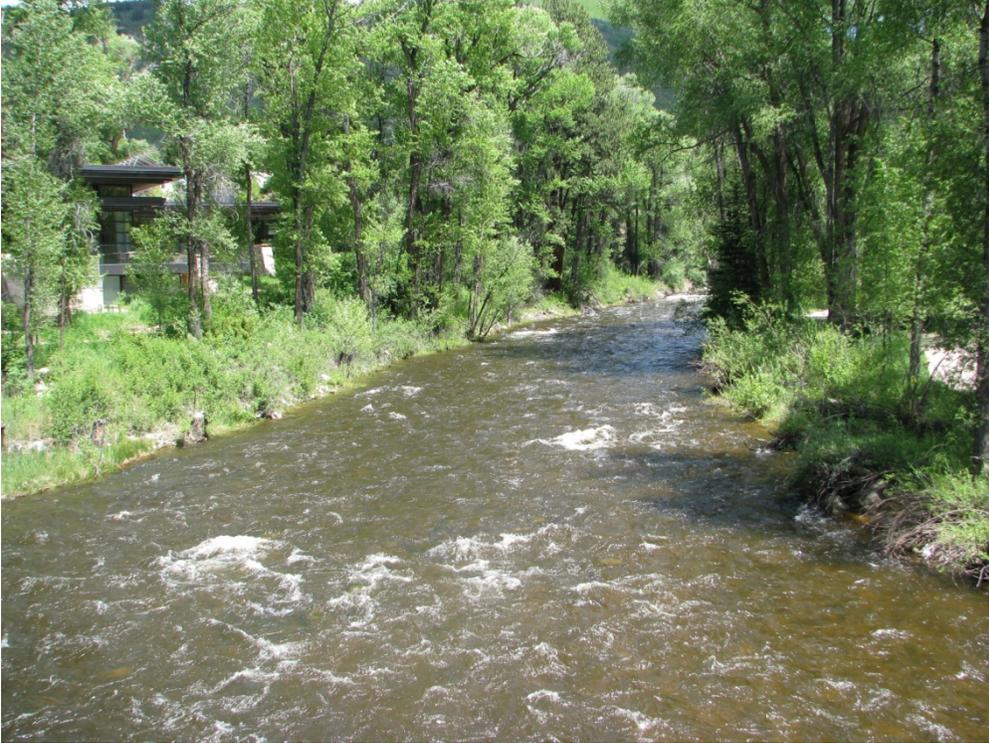
Figure D-3. Downstream end of the site looking upstream, 450 cfs (high flow), June 13, 2011.

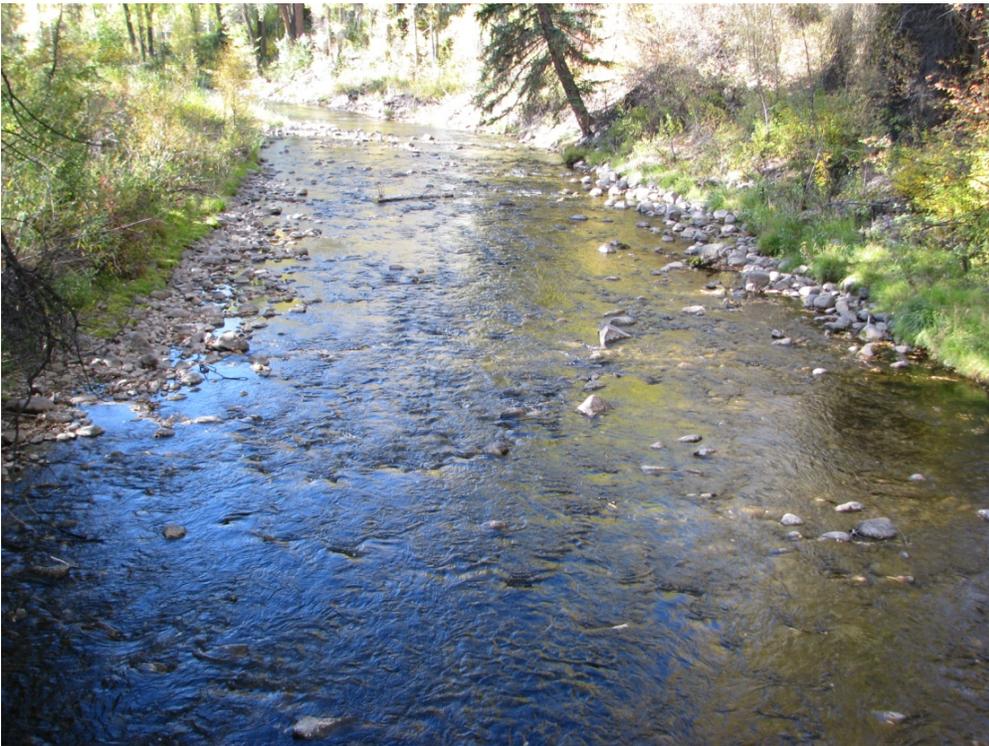
Figure D-4. Downstream view from the pedestrian bridge, 17.5 cfs (low flow), September 28, 2010.

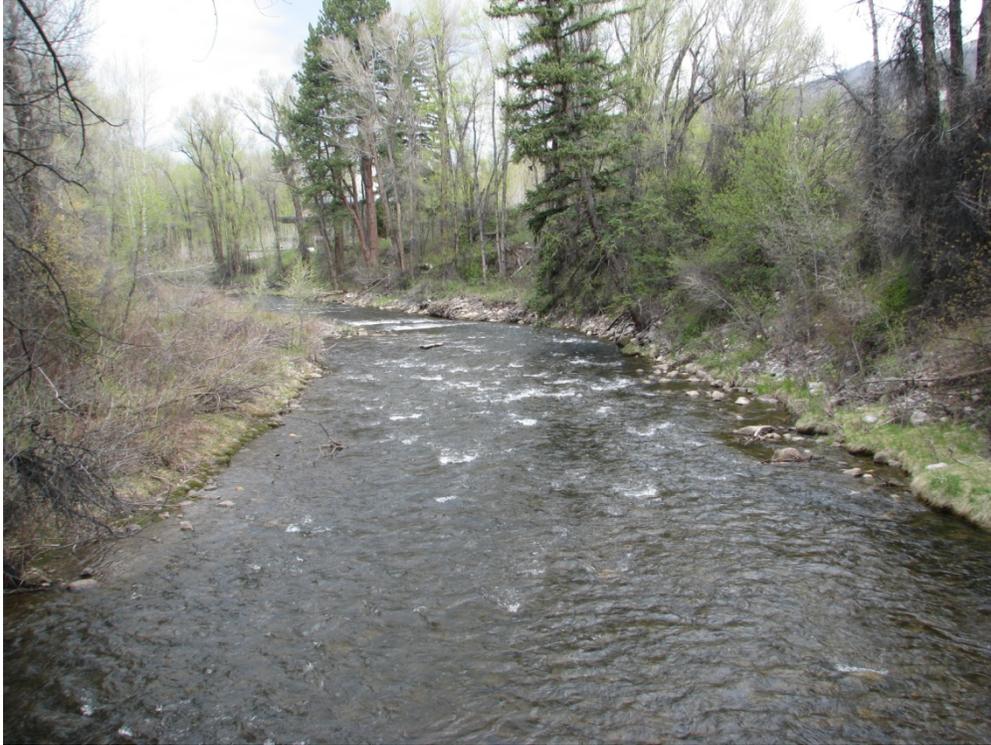
Figure D-5. Downstream view from the pedestrian bridge, 98 cfs (mid flow), May 23, 2011.

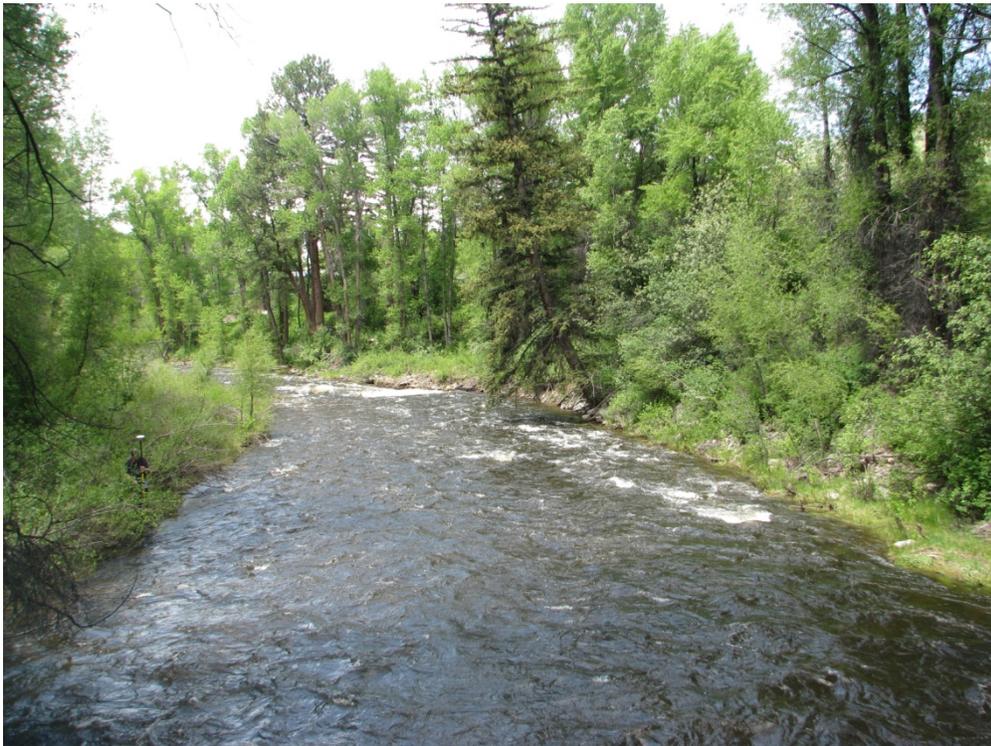
Figure D-6. Downstream view from the pedestrian bridge, 450 cfs (high flow), June 13, 2011.

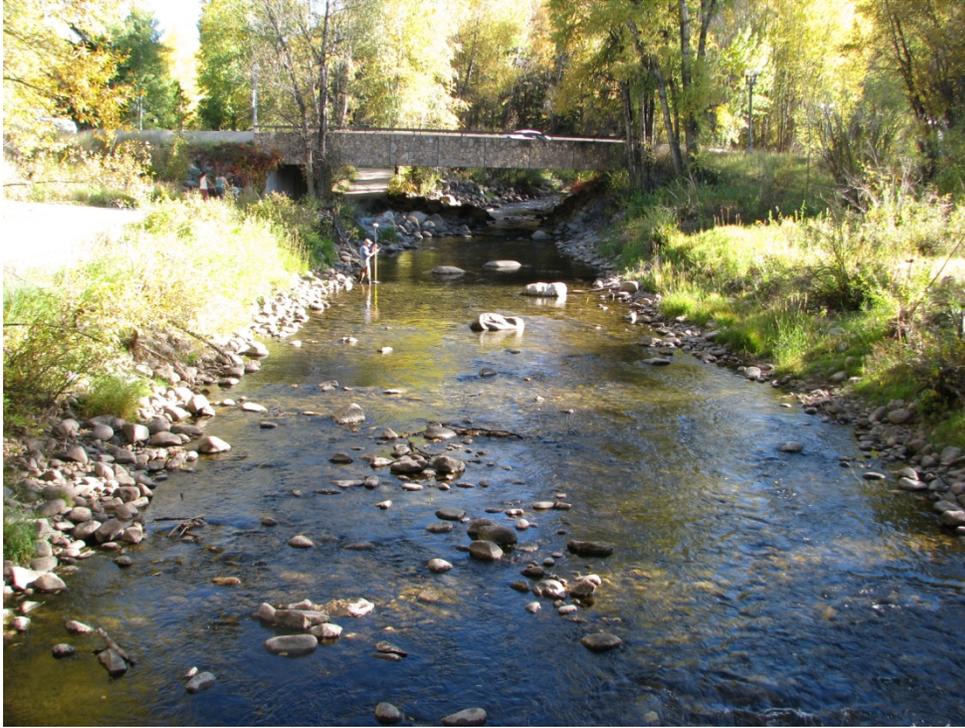
Figure D-7. Upstream view from the pedestrian bridge looking toward the Mill Street bridge, 17.5 cfs (low flow), September 28, 2010.

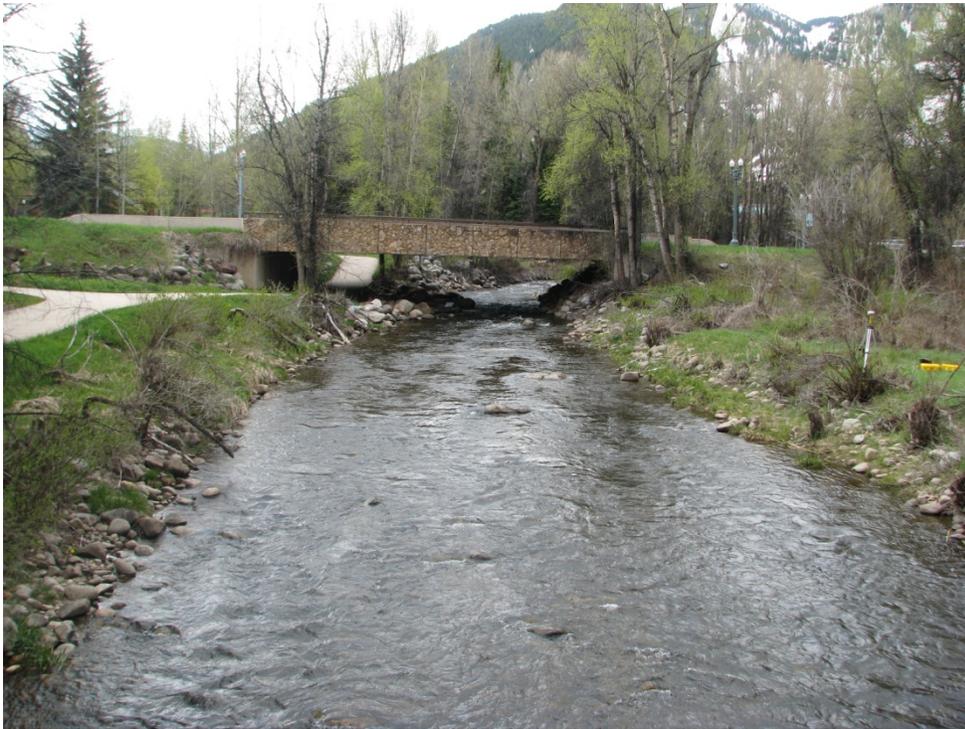
Figure D-8. Upstream view from the pedestrian bridge looking toward the Mill Street bridge, 98 cfs (mid flow), May 23, 2011.

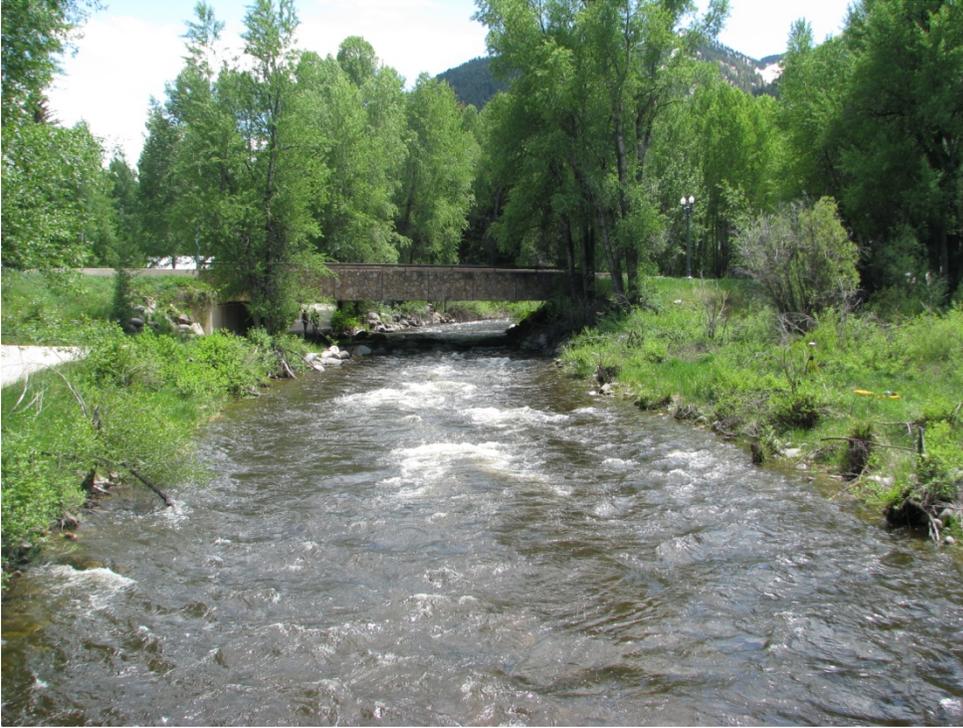
Figure D-9. Upstream view from the pedestrian bridge looking toward the Mill Street bridge, 450 cfs (high flow), June 13, 2011.

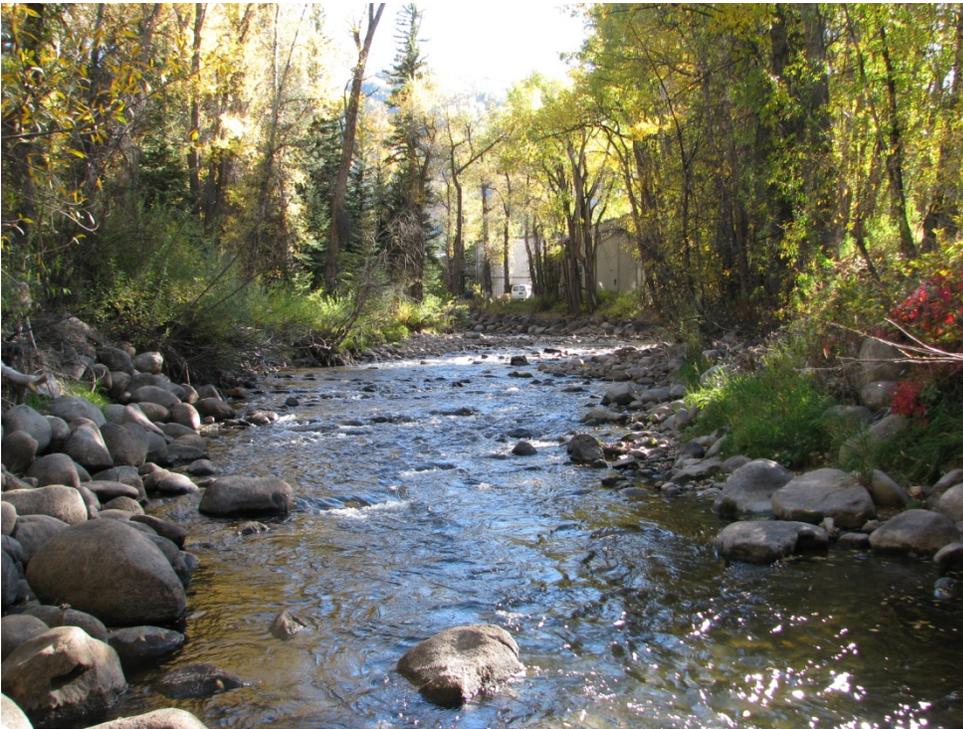
Figure D-10. View from the Mill Street bridge looking upstream toward the upper end of the site, 17.5 cfs (low flow), September 28, 2010.

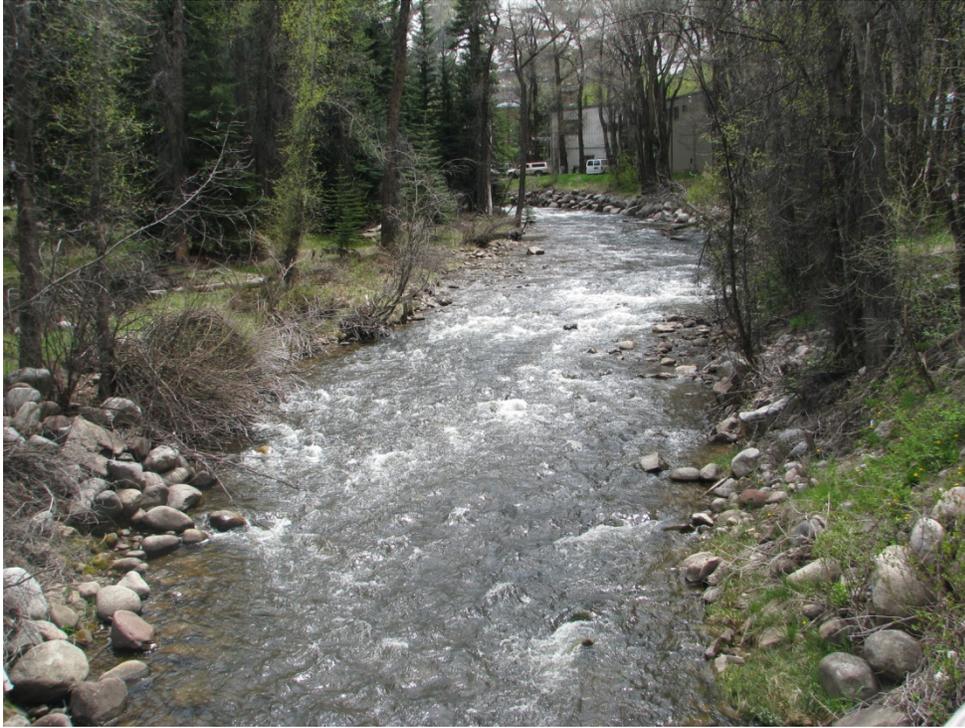
Figure D-11. View from the Mill Street bridge looking upstream toward the upper end of the site, 98 cfs (mid flow), May 23, 2011.

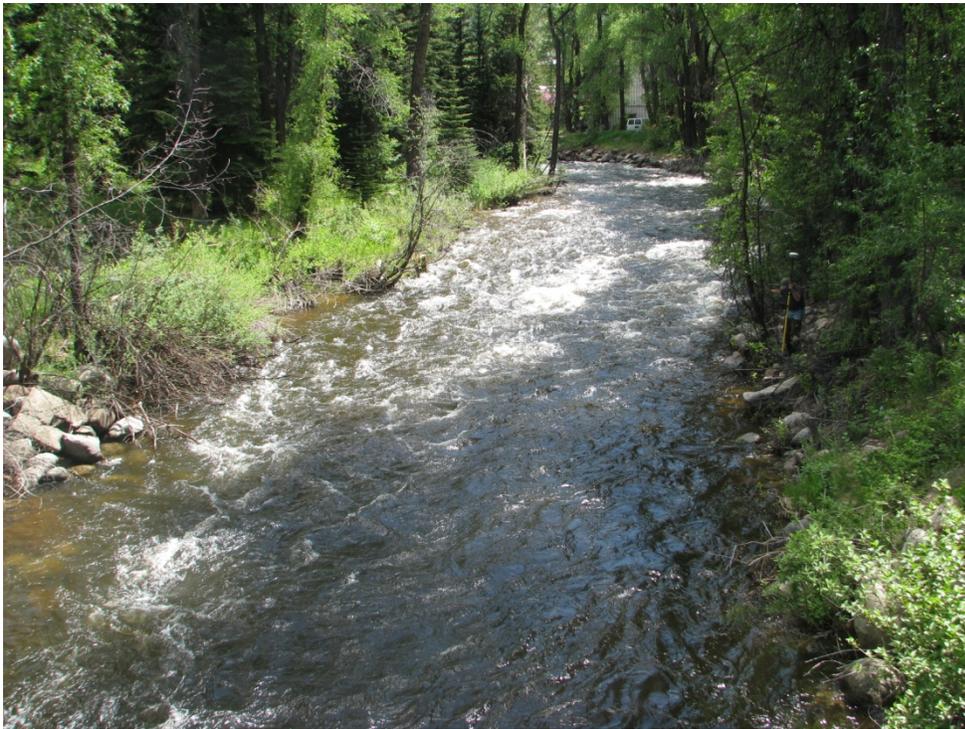
Figure D-12. View from the Mill Street bridge looking upstream toward the upper end of the site, 450 cfs (high flow), June 13, 2011.

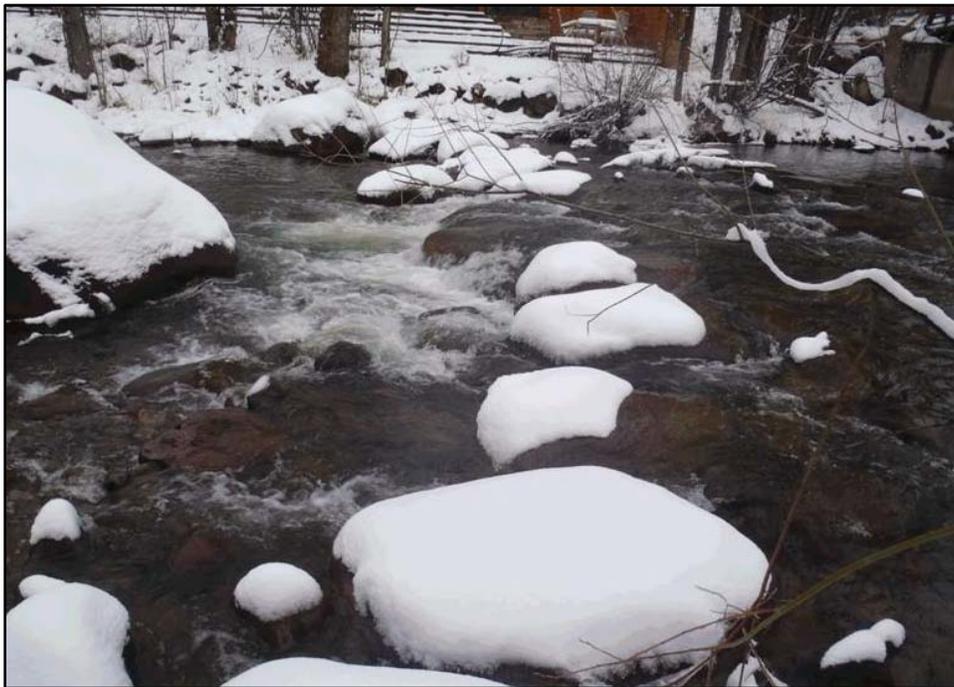
Figure 12. View looking toward the right bank showing Structure #2 just downstream of the Oklahoma Flats Trail pedestrian bridge at Newbury Park.
