Geomorphic Assessment of the Stability of the Roaring Fork River Through the City of Aspen, Pitkin County, Colorado

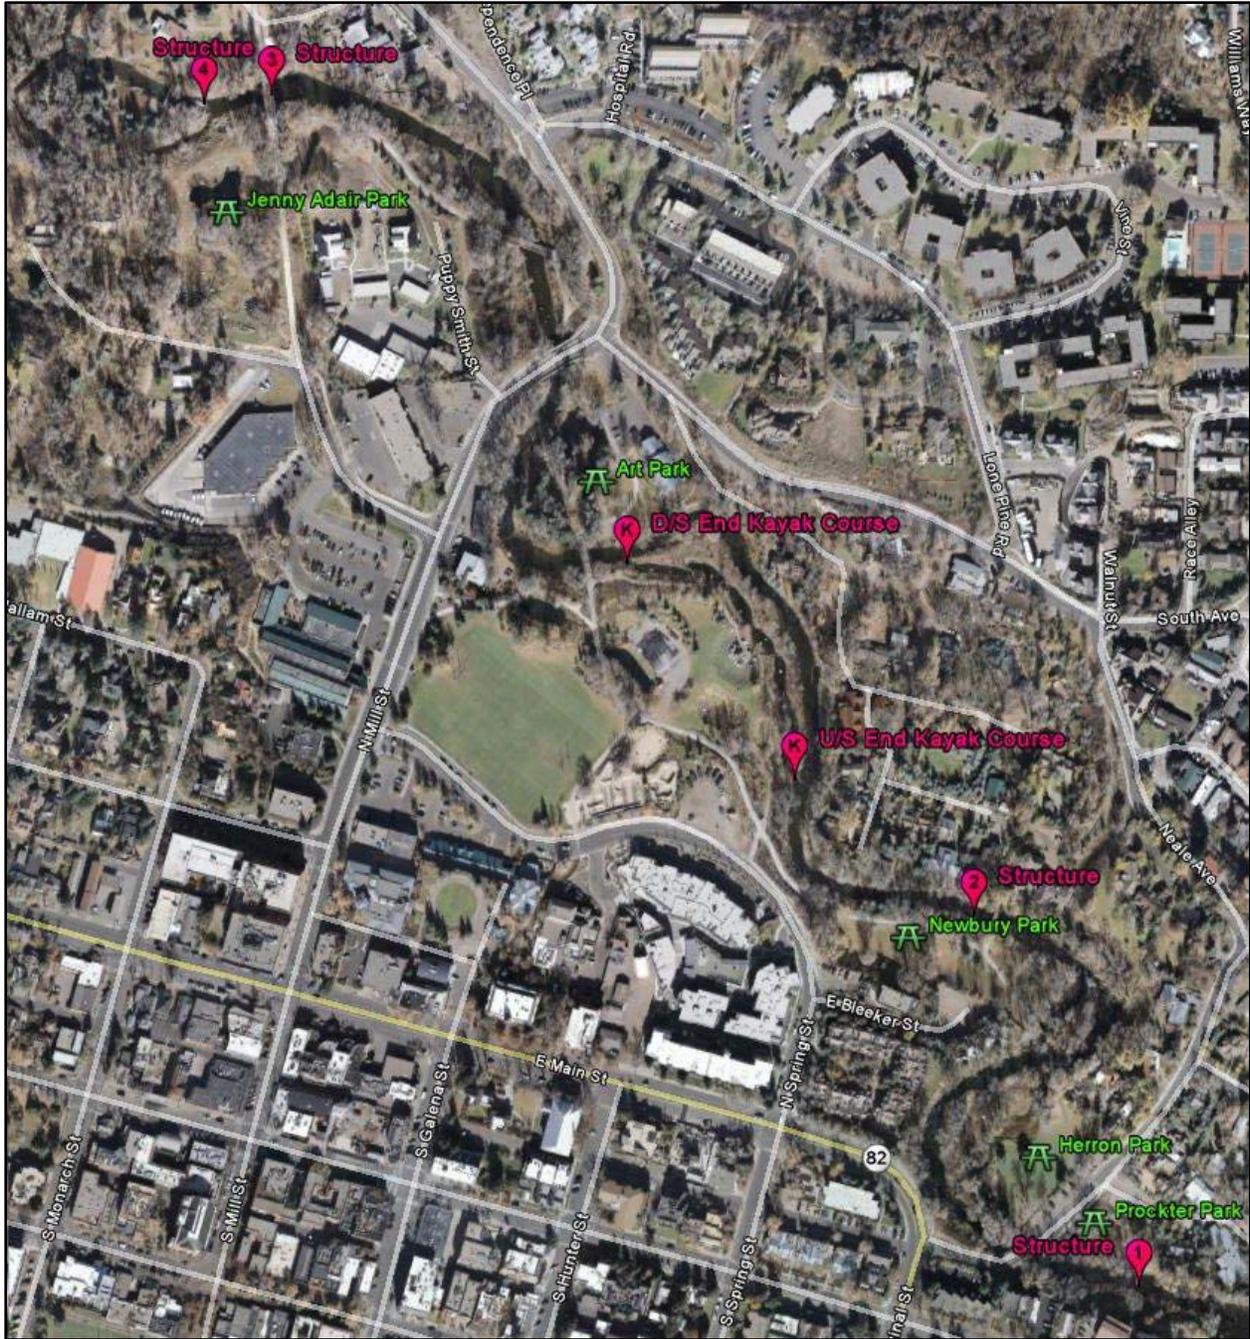
Figure 2. Aerial view (2008) of the subreach of the Roaring Fork River in which a more detailed geomorphic assessment was conducted. Man-made in-channel features are shown in red.

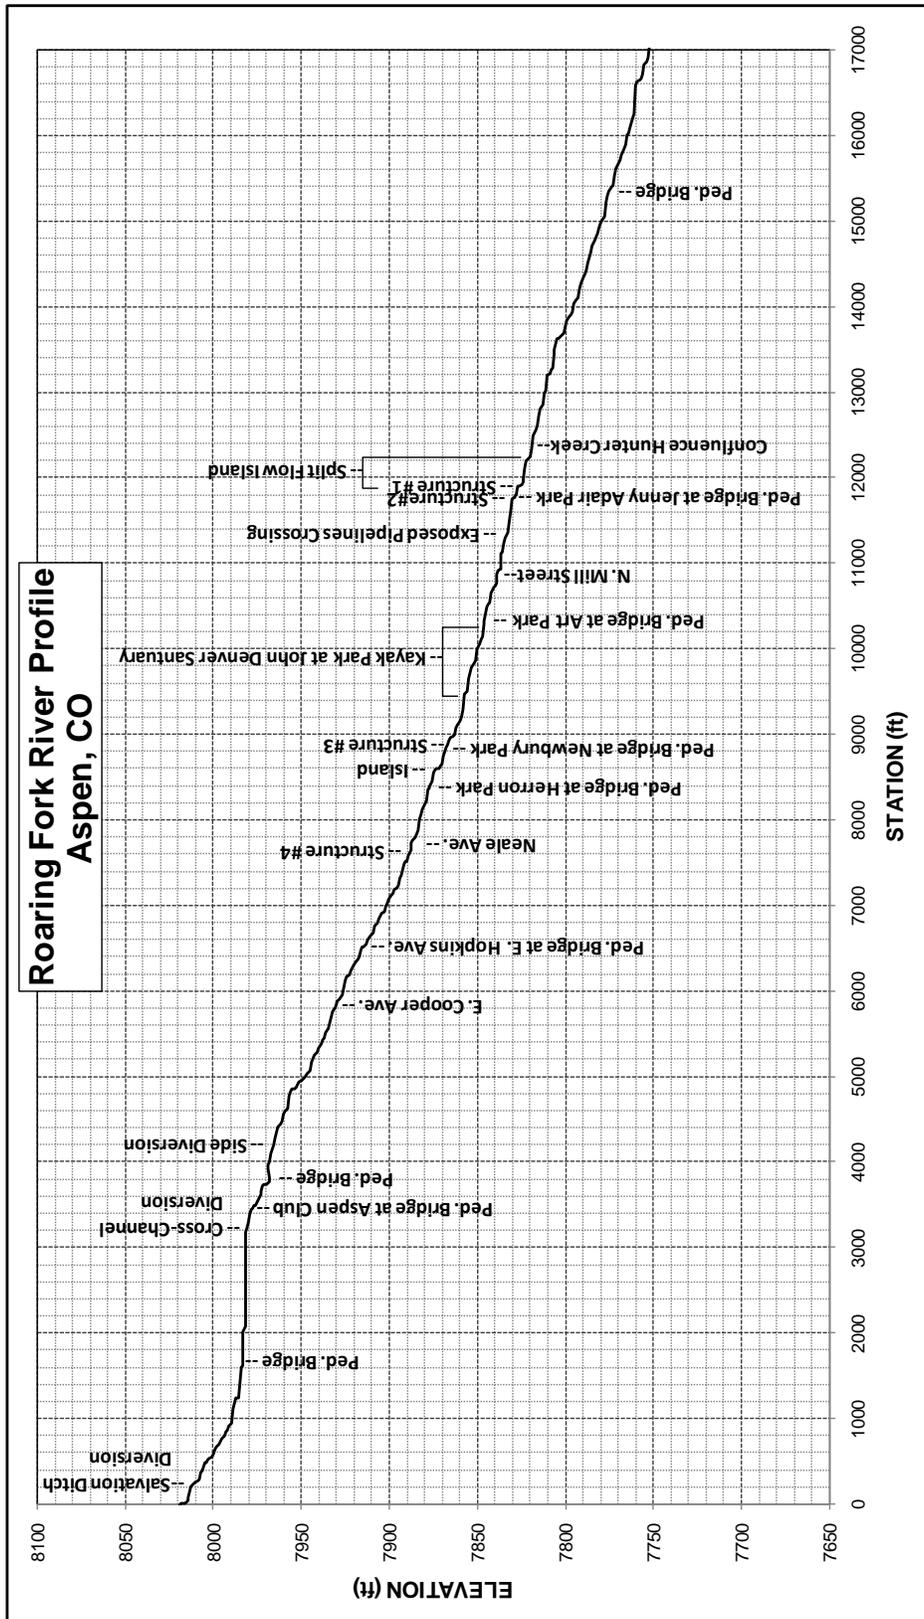
Figure 3 shows the longitudinal profile of the overall project reach of the river as obtained from the 1-ft contour mapping provided by the County. **Figure 4** shows the subreach of interest as described above. **Table 1** shows the overall channel slope for segments of the river through town. As can be seen in Figures 3 and 4 and Table 1, river channel slopes are greatest between the Aspen Club and Neale Avenue, but decrease significantly below Neale Avenue. These slope changes can be tied directly to the geology of the valley floor in this area. Based on the geologic mapping of the valley (Bryant 1971), the relatively flat portion of the profile just upstream of the Aspen Club corresponds with a highly meandering segment of the river in a short but fairly wide, unconfined, alluvial section of the valley. An analysis of the contour mapping for the Aspen area also reveals that the valley floor in the area of the Aspen Club is

Figure 3. Longitudinal profile of the overall project reach of the Roaring Fork River through Aspen, CO.

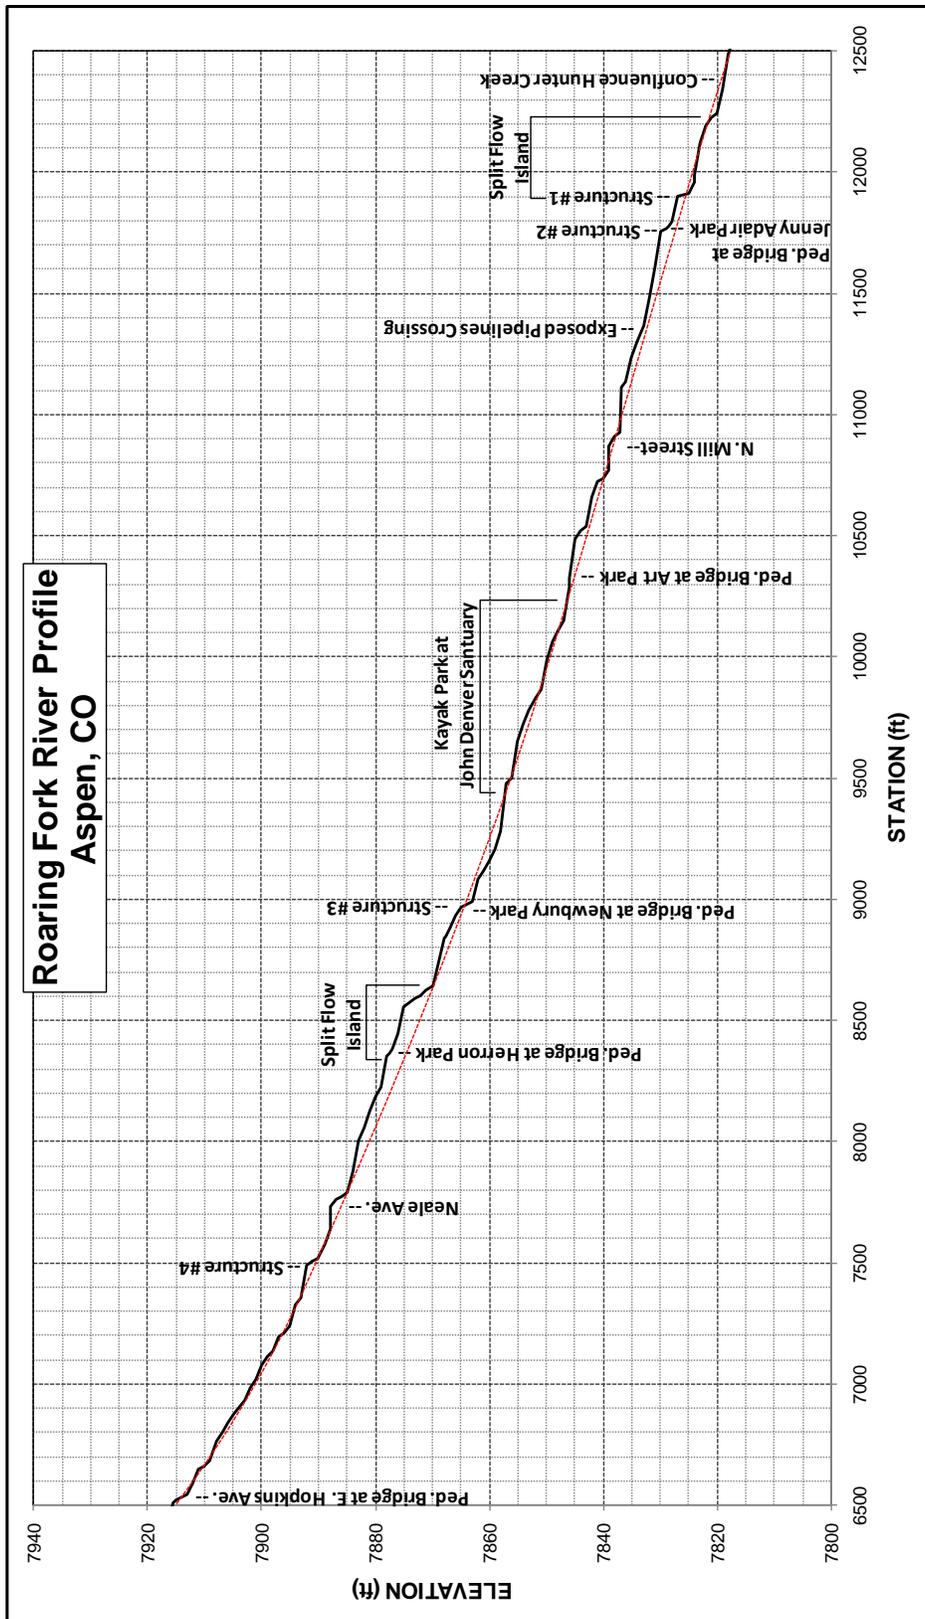
Figure 4. Longitudinal profile of the subreach of interest of the Roaring Fork River through Aspen, CO. The red line is a best fit line used to highlight significant channel profile changes.

The river then makes a sharp turn toward the west below the Herron park pedestrian bridge and the island just downstream. The right bank at this location is a high steep bank composed of glacial outwash material, with the toe of the bank armored by boulders eroded from the bank. The river slope is fairly steep through this segment as seen in Figure 4.

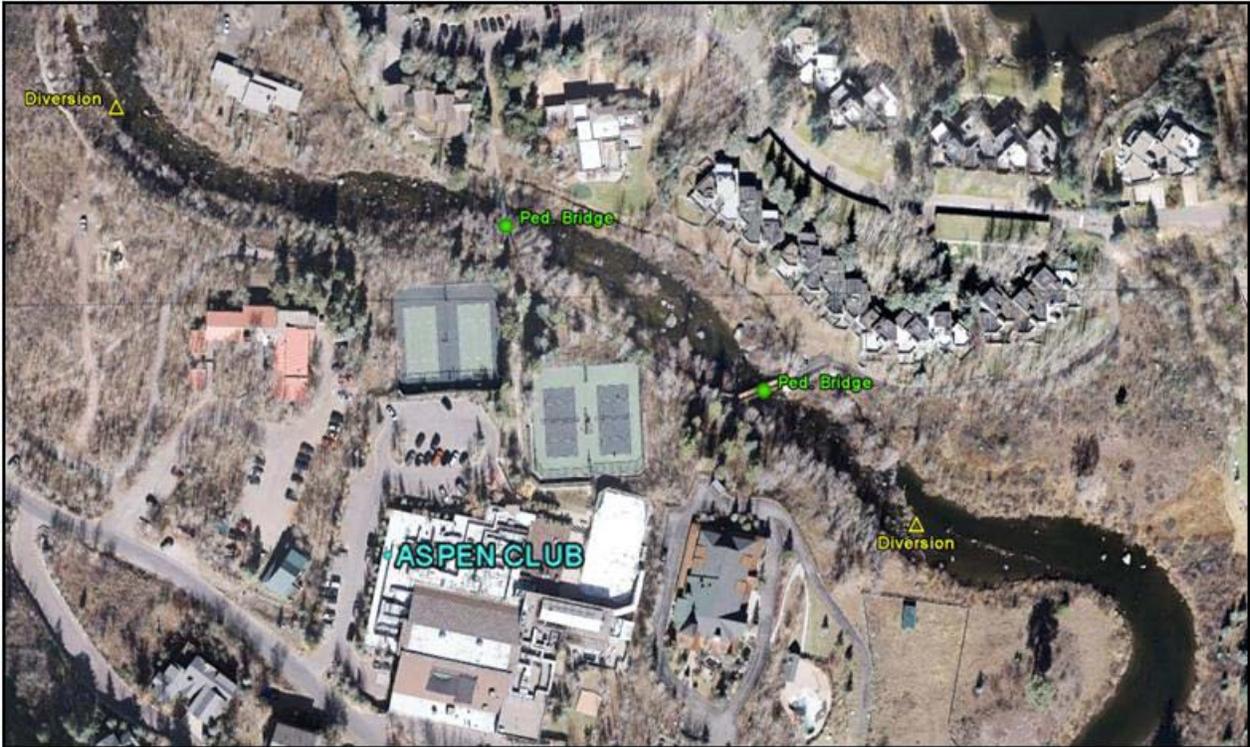
Figure 6. Aerial view of the river in the area of the Aspen Club showing the location of existing diversion structures and pedestrian bridges.

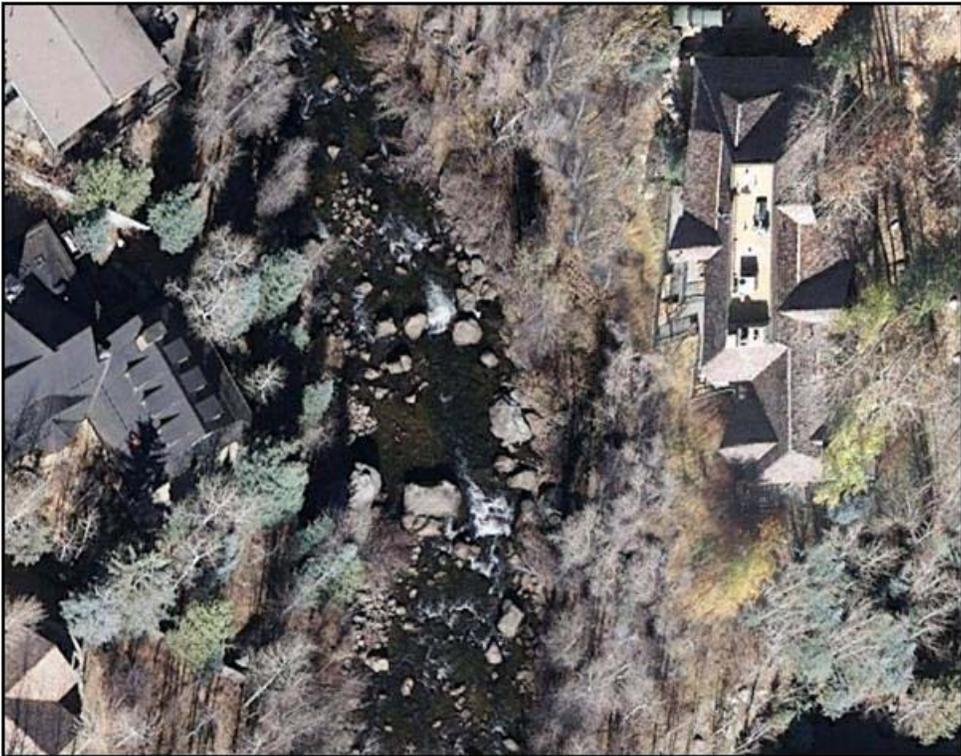
From the Aspen Club downstream to the Neale Avenue bridge, the river steepens, is much less sinuous, and becomes confined by urban development that encroaches on the river. This segment of the river contains a number of typical boulder riffles and pools (**Figure 7**) with a long, narrow split flow island just upstream of the E. Cooper Avenue bridge. None of these features poses an impediment to fish passage at low flow. In fact, the boulder clusters, which do not obstruct fish passage, do produce localized upstream backwatering and scour on the downstream side of the boulders, which is optimal habitat for fish.

Figure 7. Aerial View of typical boulder riffles and pools just upstream of E. Cooper Avenue.

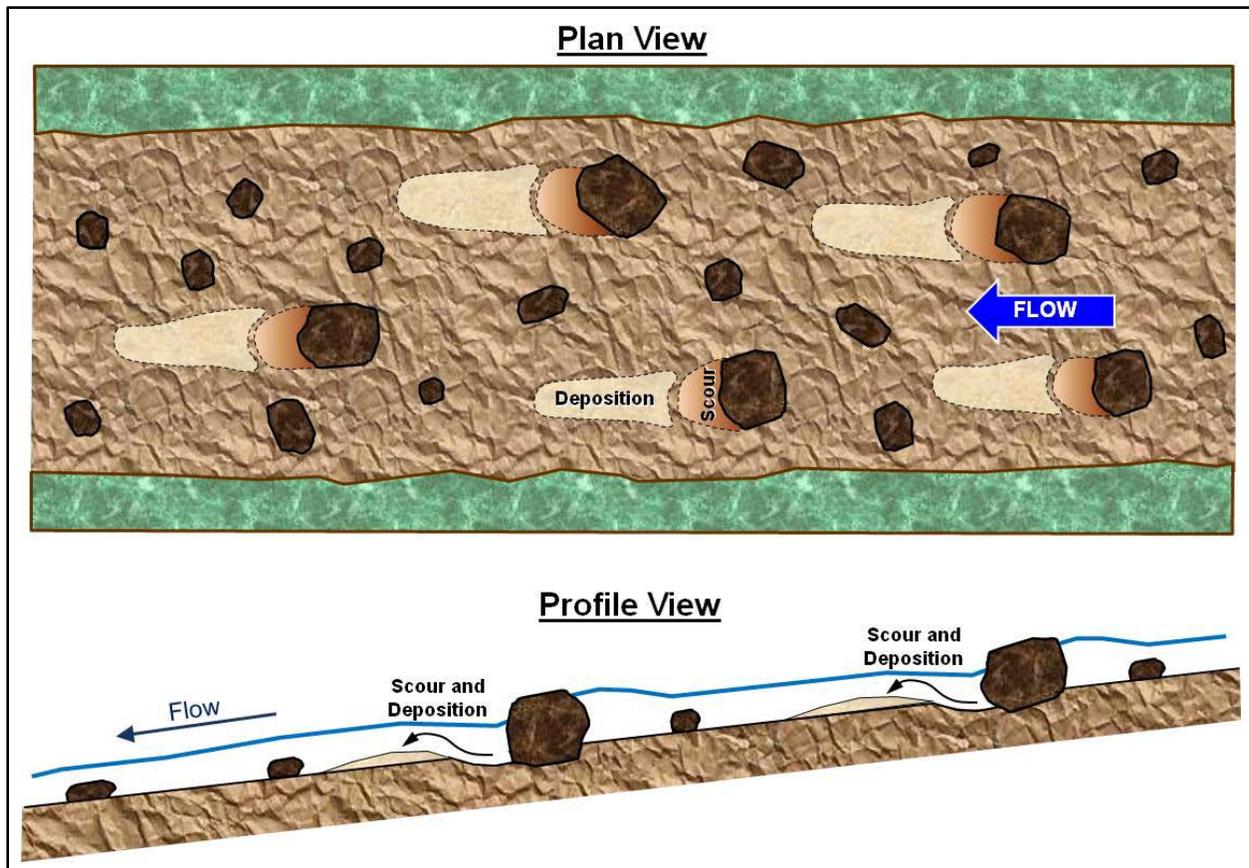
Contributing to the degraded in-stream habitat is the presence of boulder grade control structures emplaced to protect exposed utility crossings and to provide flow to man-made split flow channels. These structures create significant vertical drops that are an impediment to fish passage as well as inducing localized upstream aggradation that reduces the flow depth, increases the channel width through bank erosion, and buries spawning substrates within the aggraded reach. For example, **Figure 23** shows the plan and profile view a typical steep, unobstructed, boulder/cobble bed channel like the Roaring Fork River. In this view, it can be seen that water "piles up" on the upstream side of a large boulder and then accelerates as it goes around the boulder. As flow passes around the boulder, flow acceleration and eddying may create a scour hole on the downstream side of the boulder. Minor amounts of localized sediment deposition may occur just downstream of the boulder, both a result of the scour and as a result of the boulder creating a shadow zone. The individual boulder, its scour hole, and the minor sediment deposition downstream all create diverse habitat for fish.

Figure 23. Typical flow, scour, and deposition patterns on a steep, boulder/cobble bed stream.
